MPC8323E Chip Errata

This document details all known silicon errata for the MPC8323E and MPC8321E. The following table provides a revision history for this document.

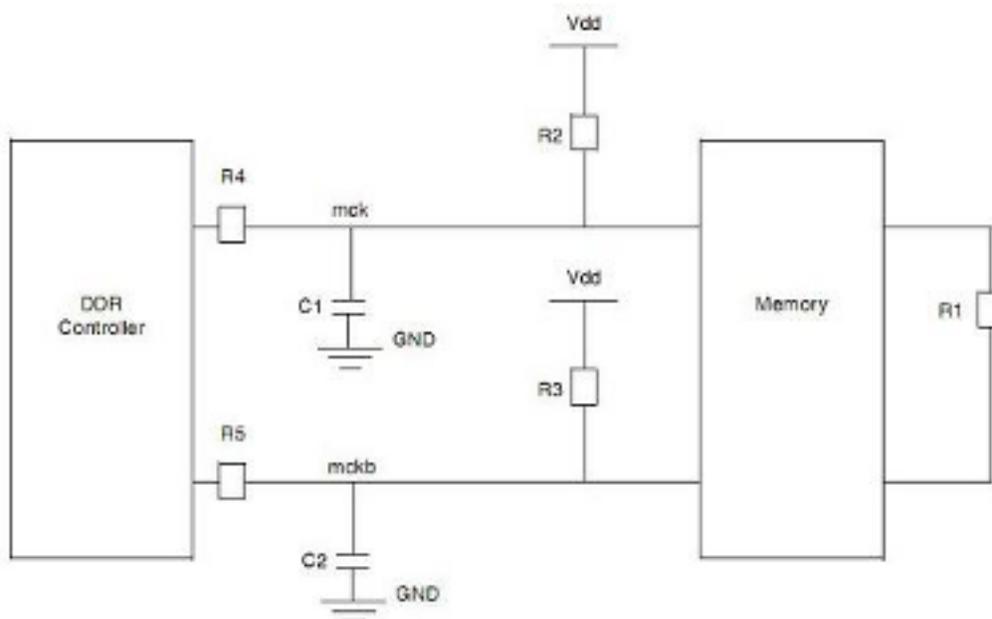
Figure 1. Recommended connections for DDR controller and memory

Impact: Disagreement with the JESD79-2C standard.

Workaround: To meet the JESD79-2C crosspoint voltage specifications, we recommend implementing the following connections between the DDR controller and DDR2 memory:

We recommend varying termination resistor R1 first. Lowering R1 can help increase the voltage levels up. The only disadvantage is that it may add up more reflections. Therefore, the user must decide accordingly. If it does not give sufficient margin, the user can add the pull-up resistor (R3 and R4) option to further increase the voltage levels.

Exact values of components vary from design to design and some of them may not be required for all designs. We recommend that you make provisions for all these options in your design.

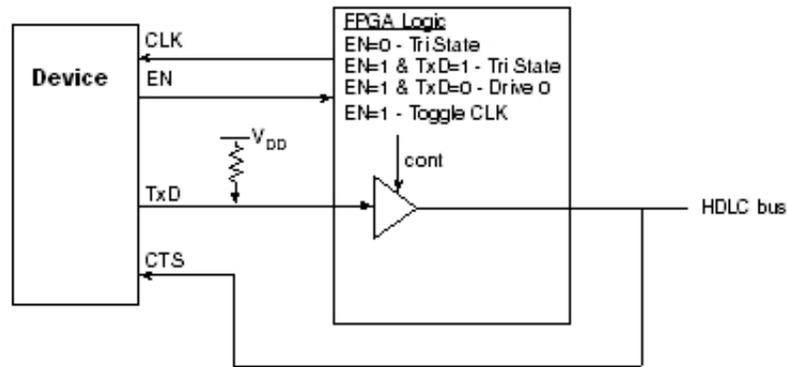
Figure 2. External Logic To Generate Gated Clock for the UCC

Impact: HDLC bus mode is not supported through the TDM interface.

Workaround: Program the UCC to NMSI mode and use external logic to generate the gated clock for the UCC at the assigned time slot, see Figure 1 below.

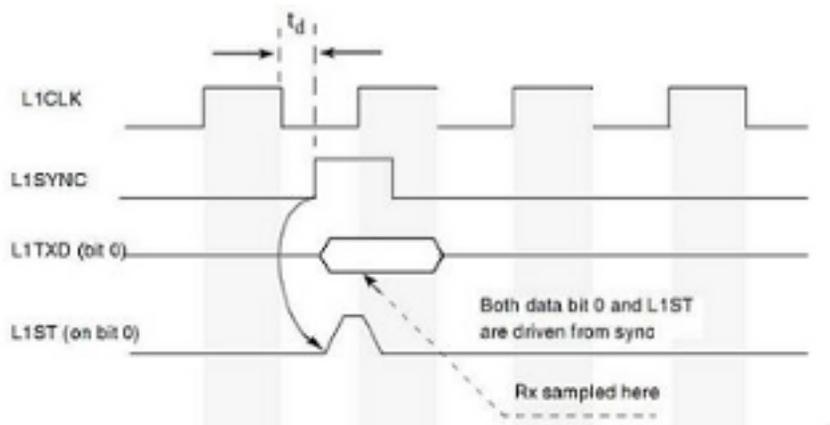
Figure 3. Falling Edge (FE) Effect When CE=1, FE=1 and xFSD=00.Sync starts before rising edge

The clock ratio between the TDM clock and the QE clock is limited to 1:24 (the TDM clock can not be faster than QE clock divided by 24), except for the following clock to sync relationship:

- The limitation is 1:32 when $SlxMR[CE] = SlxMR[FE]$, $SlxMR[TFSD] = 00$, and the sync has the timing shown in Figure 1 and Figure 2. In these configurations, $SlxMR[8]$ should be set and in addition to this limitation, the maximum delay between L1CLK and L1SYNC t_d should be less than 8 QE clocks.

Impact: Maximum TDM data rate cannot be achieved.
