# Device Errata for the MPC850 Family

This document is a compilation of all MPC850 family device errata from silicon Revision 0.0 forward. Herein, the errata are classified and numbered, and each erratum is provided with a description and workarounds.

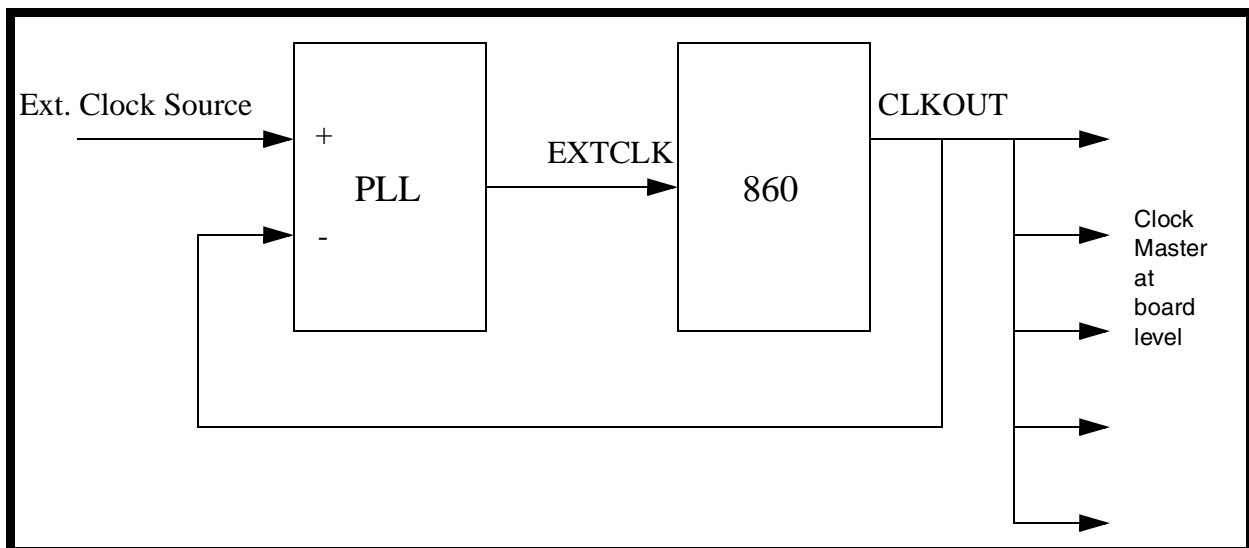
**G4 Potential problems caused by skew between EXTCLK and CLKOUT**

Important Note: The PLL has to be capable of operating with a permanent offset of -2nS, therefore the range of lock should extend to about -4nS.

A diagram of this concept is given below:

**Projected Solution:**

Corrected in Revision B.
