MPC860/855T Family Device Errata Reference

This document is a compilation of all MPC855T, MPC860, MPC860SAR, and MPC860T device errata from Revision A.2 forward. Herein, the errata are classified and numbered, and each erratum is provided with a description and workarounds in the second part of the document. To determine which silicon revision and mask set are associated with which version, please refer to [Table 2](#). To find which errata apply to a particular device, please refer to the errata listings for each revision provided in [Table 4](#). Indications of schedules for errata fixes are provided in the errata listing of the latest revision of each part.

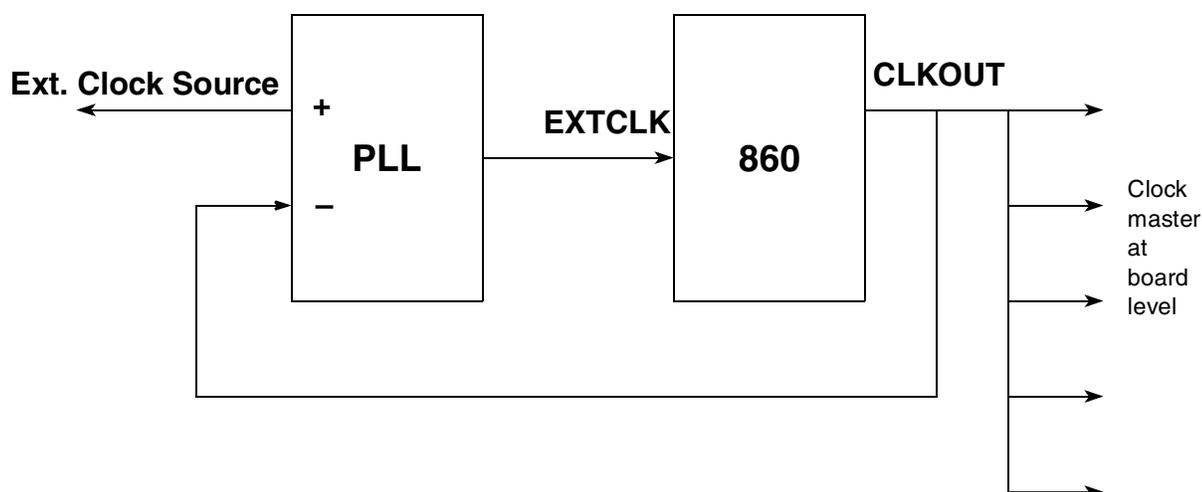
Figure 1. Workaround for Case 2

G4 Potential problems caused by skew between EXTCLK and CLKOUT

The PLL must be capable of operating with a permanent offset of -2nS, therefore the range of lock should extend to about -4nS.

A diagram of this concept is given in [Figure 1](#).
