Chip Errata for the MPC885 Duet Family

This document details all known silicon errata for the MPC885, MPC880, MPC875, and MPC870 Duet family. The MPC885 has the same functionality as the MPC880, MPC875, and MPC870, and any differences are detailed in the reference manual. [Table 1](#) provides a revision history for this device errata document.

Table 2. MPC885/MPC875 Summary of Silicon Errata and Applicable Revision

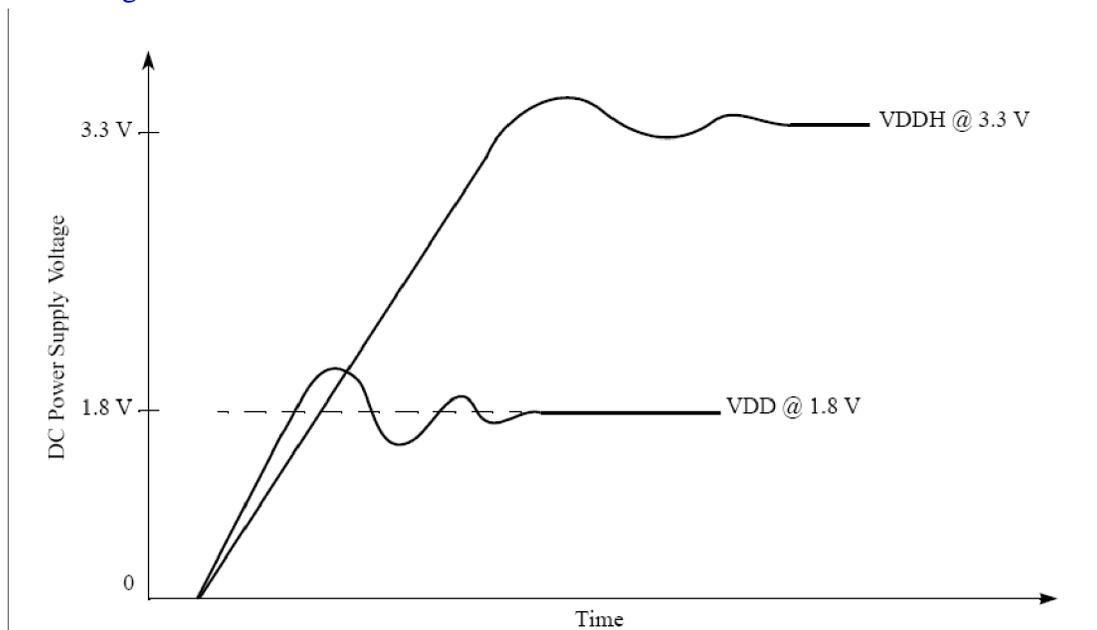
Figure 1. Power Supply Ramping

If core supply voltage (VDDL) is below recommended operating conditions while I/O supply voltage (VDDH) is high during a power-on reset sequence, I/O pins (including those designated input only) might drive a value instead of being Hi-Z. This could confuse connected devices and, in turn, cause the PowerQUICC device to behave improperly. Affected pins include such interfaces as the communication parallel I/O, reset, address and data bus pins, and JTAG pins.

The value a pin may drive is random. As soon as core voltage has stabilized at its nominal level within recommended operating conditions, all pins will behave normally and the PowerQUICC will continue to function properly.

It is recommended that VDDL/VDDSYN be raised before or simultaneously with VDDH during the power-on reset sequence; that is, while $VDDH \leq$ recommended operating condition for VDDL/VDDSYN during ramp of all voltages, it should be ensured that $VDDL/VDDSYN \geq$ VDDH at all times.

If the power supply design cannot be altered as recommended, then any logic connected to the PowerQUICC which may react or be affected in an undesirable manner by unexpected low or high signal values during power ramp up should be appropriately secured in the design. Using SDRAM as an example, it is usually sufficient to connect the CKE input to PORESET. The practice of tying CKE high may not be safe and may lead to an unrecoverable system state.
