## Mask Set Errata

MSE908AS60\_3J74Y  
12/2002

Mask Set Errata for 908AS60,  
Mask 3J74Y

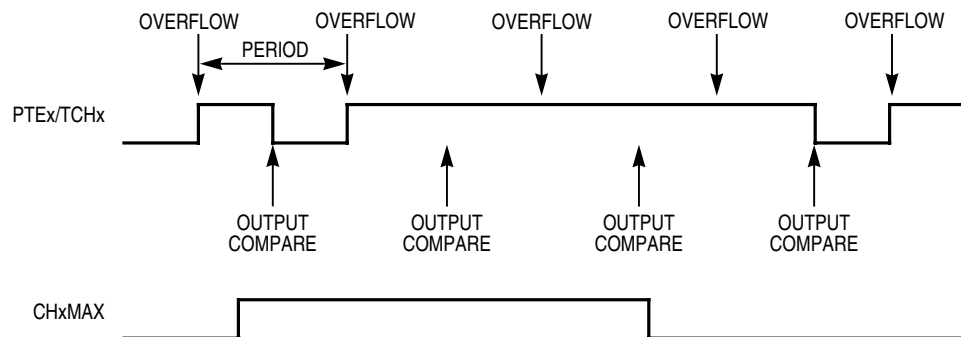
The PWM 100% duty cycle is defined as output high all of the time. To generate the 100% duty cycle, use the CHxMAX bit in the TSCx register.

When the TOVx is at logic 1 and clear output on compare is selected, setting the CHxMAX bit forces the duty cycle of buffered and unbuffered PWM signals to 100%. As this figure shows, the CHxMAX bit takes effect in the cycle after it is set or cleared. The output stays at 100% duty cycle level until the cycle after CHxMAX is cleared.

**NOTE:** The PWM 0% duty cycle is defined as output low all of the time. To generate the 0% duty cycle, select clear output on compare and then clear the TOVx bit (CHxMAX=0).
