Mask Set Errata

MSE908AS60_6J61D
12/2002

Mask Set Errata for 908AS60,
Mask 6J61D

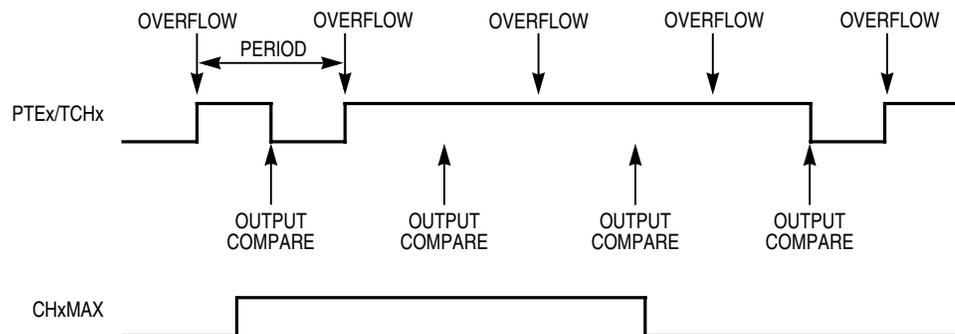
When the TOVx is at logic 1 and clear output on compare is selected, setting the CHxMAX bit forces the duty cycle of buffered and unbuffered PWM signals to 100%. As this figure shows, the CHxMAX bit takes effect in the cycle after it is set or cleared. The output stays at 100% duty cycle level until the cycle after CHxMAX is cleared.

The PWM 100% duty cycle is defined as output high all of the time. To generate the 100% duty cycle, use the CHxMAX bit in the TSCx register.

NOTE: The PWM 0% duty cycle is defined as output low all of the time. To generate the 0% duty cycle, select clear output on compare and then clear the TOVx bit (CHxMAX=0).
