Mask Set Errata for Mask 3K45H

This mask set errata applies to the mask 3K45H for these products:

- MC68HC908JB8

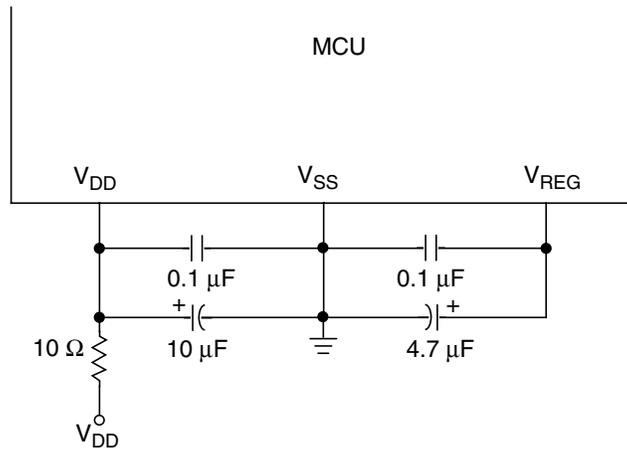
A few devices start abnormally during power-up. The issue is the release of the low voltage reset (LVR) earlier than the V_{REG} reaching the CMOS logic operating voltage (typical 0.65 V).

The LVR takes the V_{DD} but not the V_{REG} as a reference. LVR exists until the V_{DD} reaches the LVR threshold voltage (V_{LVR}). The problem happens in few devices when the V_{DD} rises quickly and the V_{REG} rises slowly. If the LVR has been released but the V_{REG} doesn't reach the CMOS logic operating voltage, the LVR does not have any effect. This might cause the internal logic to improperly initialize and the MCU might not start normally.

Therefore, the V_{DD} voltage must be lower than the VLVR minimum (2.8 V) when the V_{REG} voltage reaches the CMOS logic operating voltage.

To fix the problem, add a 10 Ω series resistor between the power supply and the V_{DD} , and place a 10 μF capacitor at the V_{DD} pin and a 4.7 μF capacitor at the V_{REG} pin.

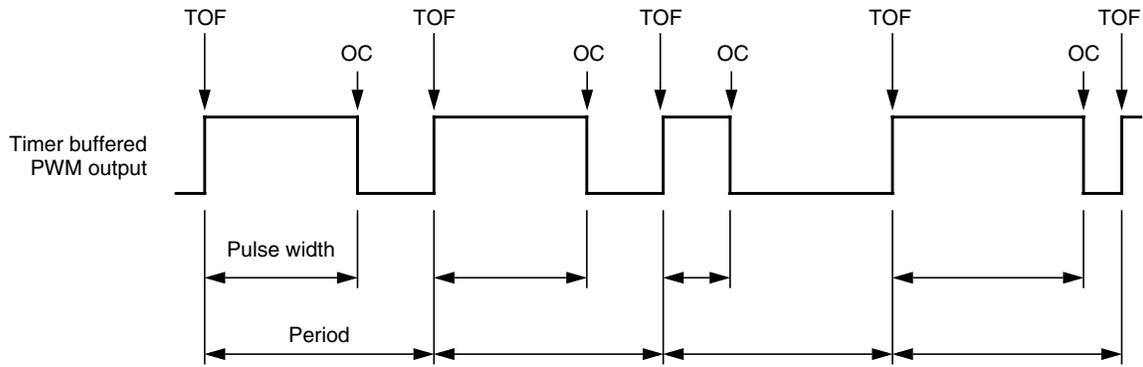
In timer buffered PWM operation, when a timer overflow (TOF) event or an output compare (OC) event coincides with a write to either pair of the timer channel registers (TCHxH/L), the duty cycle at the PWM output glitches to 0% or 100% momentarily, then returns to proper operation.

Do not write to either pair of timer channel registers at:
 TOF (timer overflow), or
 OC (timer output compare) edges.

To avoid the glitches when changing the PWM duty cycle, do not write to either pair of the timer channel registers at the TOF or OC.

For example, in the TOF interrupt service routine: If the OC occurs near the last TOF, write to the timer channel registers after the OC; if the OC occurs near the next TOF, write to the timer channel registers before the OC. A write to the channel register high byte (TCHxH) should immediately followed by a write to the low byte (TCHxL) to avoid TOF or OC occurring between the writes. Instruction cycle times must be included when making timing calculations.
