Mask Set Errata

MSE912D60A_1L02H
Rev 0, 01/2003

Mask Set Errata for
68HC912D60A
Mask 1L02H

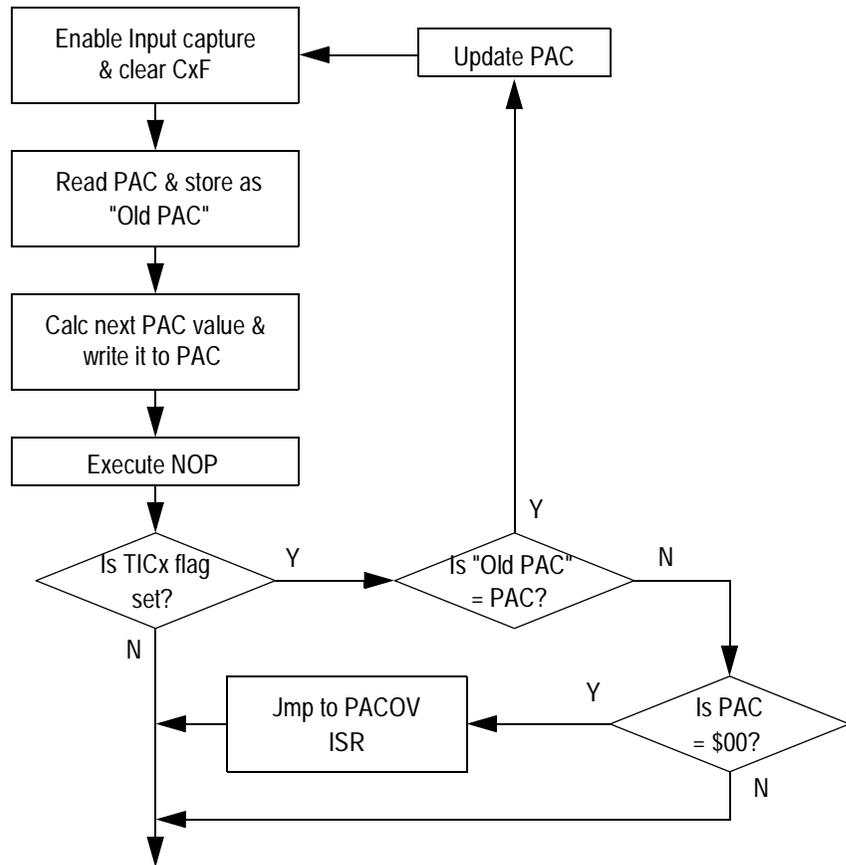
When the value \$FFFF is written to PACA or PACB and, at the same time, an external clocking pulse is applied to the PAC, the pulse accumulator may overflow from \$FFFF to \$0000, but the pulse accumulator overflow flag [PAFLG,PBFLG] is not set. Same situation may happen with 8-bit pulse accumulators PAC1 and PAC3.

The input capture function for the subject channel be enabled prior to writing a value to the PACA or PACB. Write to the pulse accumulator register. Then do one NOP (to allow the input capture to update the interrupt flag) followed by a read of the input capture interrupt flag to see if it set. If yes, a check must be made for a missing pulse accumulator event. Steps for software workaround to see if event happens while writing to PAC:

1. Enable Input Capture on same pin as the pulse accumulator (and same type of event).
2. Clear the appropriate CxF in the timer interrupt flag register.
3. Read PAC and store as "Old PAC".
4. Calculate desired PAC value and write it to the PAC.
5. Execute 1 NOP.
6. Read CxF in the timer interrupt flag register.

If flag is not set, done (no events happened while writing to the PAC).

If flag is set read PAC

If "Old PAC" = PAC, then update PAC (event happened while writing to PAC and the PAC did not capture it). Note, if the updated PAC value is \$00 jump to PACOV ISR.

If "Old PAC" does not equal PAC, does PAC = \$00 ?

If yes, jump to PACOV ISR.

If no, done (event happened while writing to the PAC and PAC captured it). Read CxF in the timer interrupt.
