## Mask Set Errata

MSE912D60A\_2K38K  
Rev 1, 01/2003

Mask Set Errata for  
68HC912D60A  
Mask 2K38K

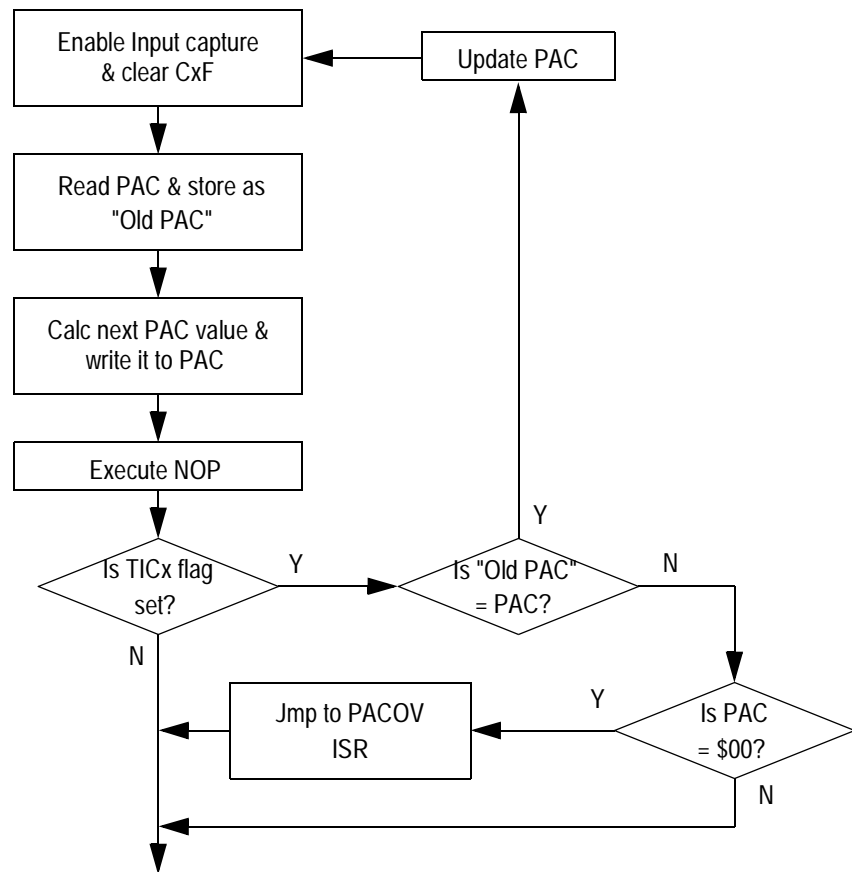
**Description** When the value \$FFFF is written to PACA or PACB and, at the same time, an external clocking pulse is applied to the PAC, the pulse accumulator may overflow from \$FFFF to \$0000, but the pulse accumulator overflow flag [PAFLG,PBFLG] is not set. Same situation may happen with 8-bit pulse accumulators PAC1 and PAC3.

**Workaround** The input capture function for the subject channel be enabled prior to writing a value to the PACA or PACB. Write to the pulse accumulator register. Then do one NOP (to allow the input capture to update the interrupt flag) followed by a read of the input capture interrupt flag to see if it set. If yes, a check must be made for a missing pulse accumulator event. Steps for software workaround to see if event happens while writing to PAC:

1. Enable Input Capture on same pin as the pulse accumulator (and same type of event).
2. Clear the appropriate CxF in the timer interrupt flag register.
3. Read PAC and store as "Old PAC".
4. Calculate desired PAC value and write it to the PAC.
5. Execute 1 NOP.
6. Read CxF in the timer interrupt flag register.
