Mask Set Errata

MSE912DG128A_0L05H
Rev 0.0, 01/2003

Mask Set Errata for
68HC912DG128A
Mask 0L05H

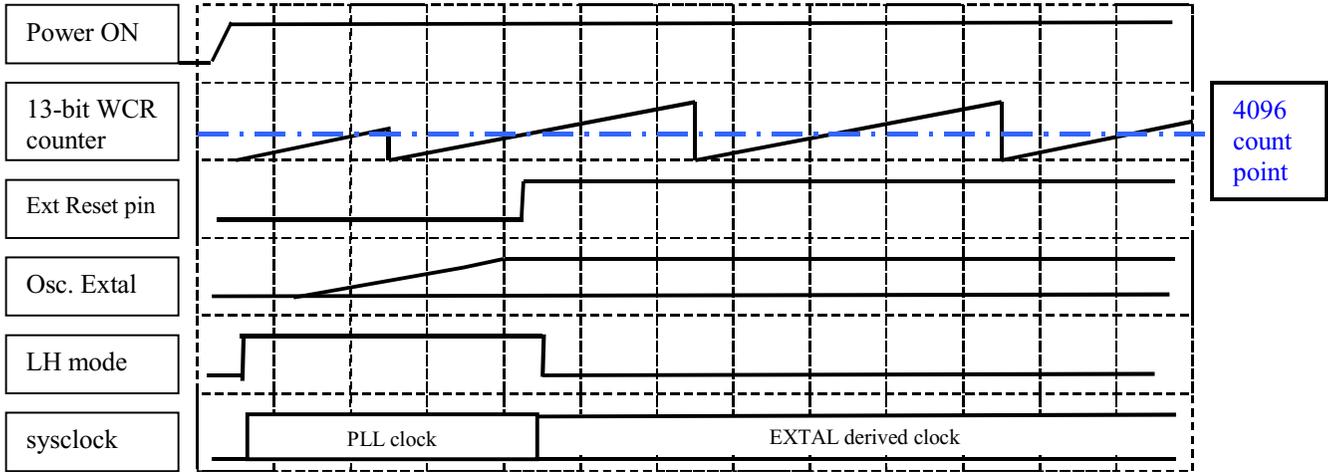
Figure 1. Representation of Normal start-up condition

Common practice for the start up mode of operation of HC12 microcontrollers is for the external RESET line to be held active until such time as the crystal has stabilized at its operating frequency. On release of the external RESET line and when the WCR (counter register) reaches a count of 4096 cycles, normal operating mode is entered with the CPU clocked from the crystal frequency (see fig. 1).

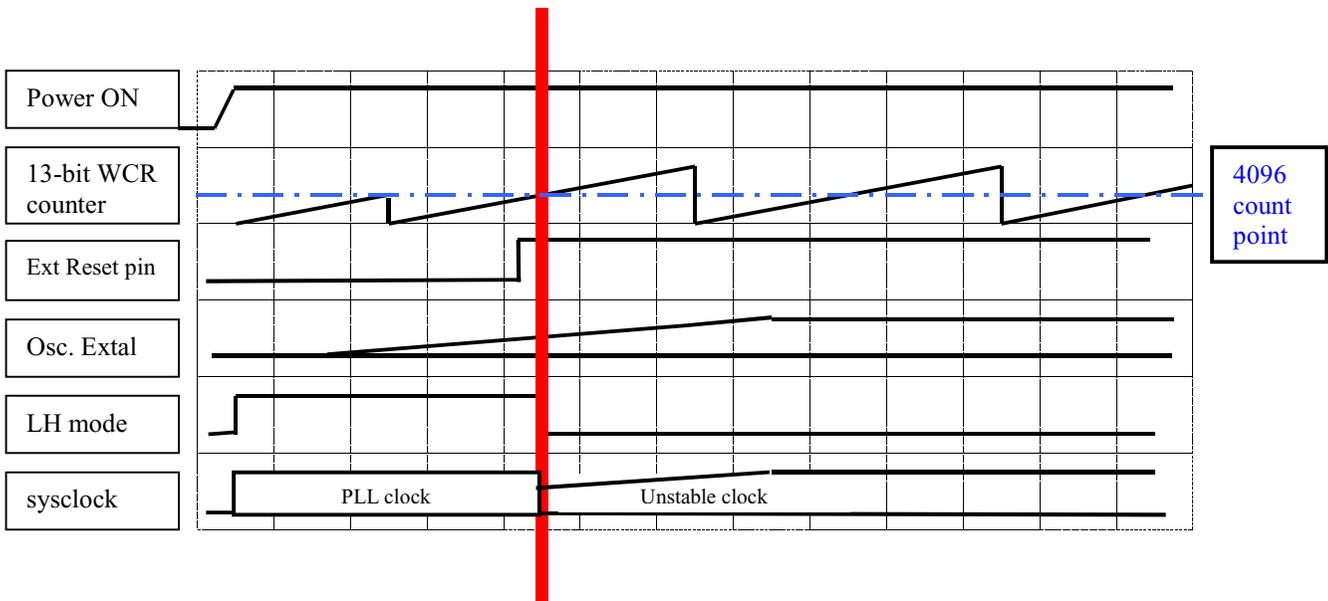
Figure 2. Representation of unreliable start-up mode with slow crystal

For the first 4096 cycles i.e. during the internal reset period, Limp Home mode will be de-asserted if oscillator activity is detected by the clock monitor circuit - due to the asserted Reset signal there can be no CPU activity during the Reset phase. Following release of the external or internal POR RESET in LHM (whichever is later) the crystal oscillator is sampled by the clock monitor circuit after another 4096 VCO clock cycles and at intervals of 8192 clock cycles thereafter until the crystal is deemed to be operating. If the crystal oscillator is showing activity at the time it is checked then it will be deemed to be good, even though it may not have fully stabilized, and LHM will be de-asserted. This can cause the device to switch from LH mode to normal mode with the CPU clocked from an unstable signal from the crystal oscillator (see fig. 2) resulting in unpredictable function of the CPU.

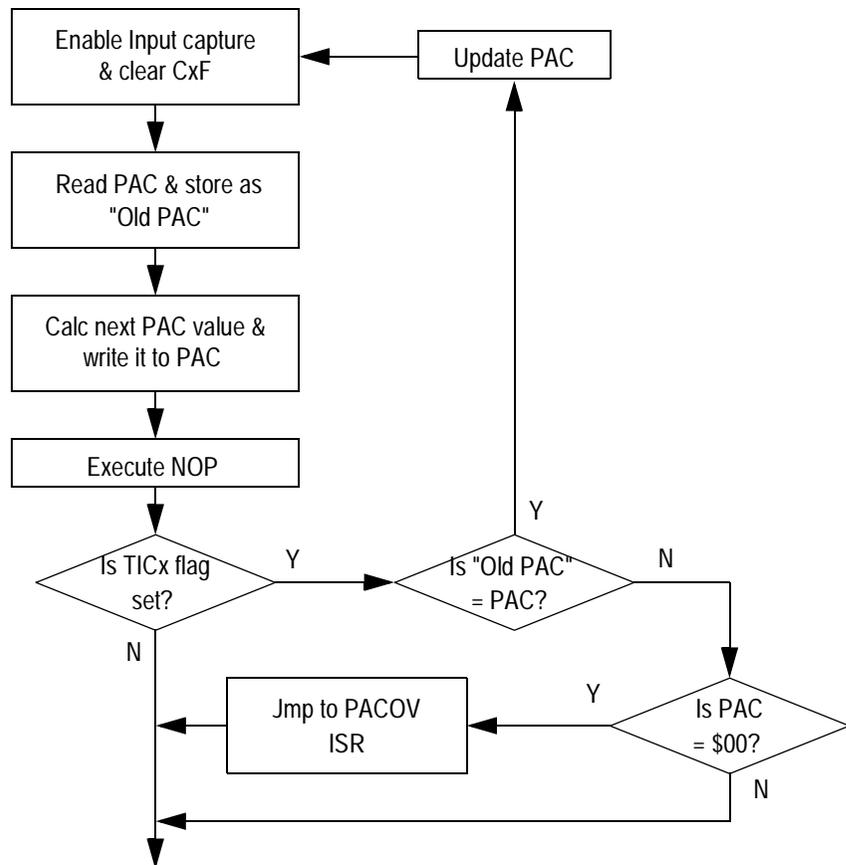
Description When the value \$FFFF is written to PACA or PACB and, at the same time, an external clocking pulse is applied to the PAC, the pulse accumulator may overflow from \$FFFF to \$0000, but the pulse accumulator overflow flag [PAFLG,PBFLG] is not set. Same situation may happen with 8-bit pulse accumulators PAC1 and PAC3.

Workaround The input capture function for the subject channel be enabled prior to writing a value to the PACA or PACB. Write to the pulse accumulator register. Then do one NOP (to allow the input capture to update the interrupt flag) followed by a read of the input capture interrupt flag to see if it set. If yes, a check must be made for a missing pulse accumulator event. Steps for software workaround to see if event happens while writing to PAC:

1. Enable Input Capture on same pin as the pulse accumulator (and same type of event).
2. Clear the appropriate CxF in the timer interrupt flag register.
3. Read PAC and store as "Old PAC".
4. Calculate desired PAC value and write it to the PAC.
5. Execute 1 NOP.
6. Read CxF in the timer interrupt flag register.
