Mask Set Errata

MSE912DG128A_4K91D
Rev 0.0, 01/2003

Mask Set Errata for
68HC912DG128A
Mask 4K91D

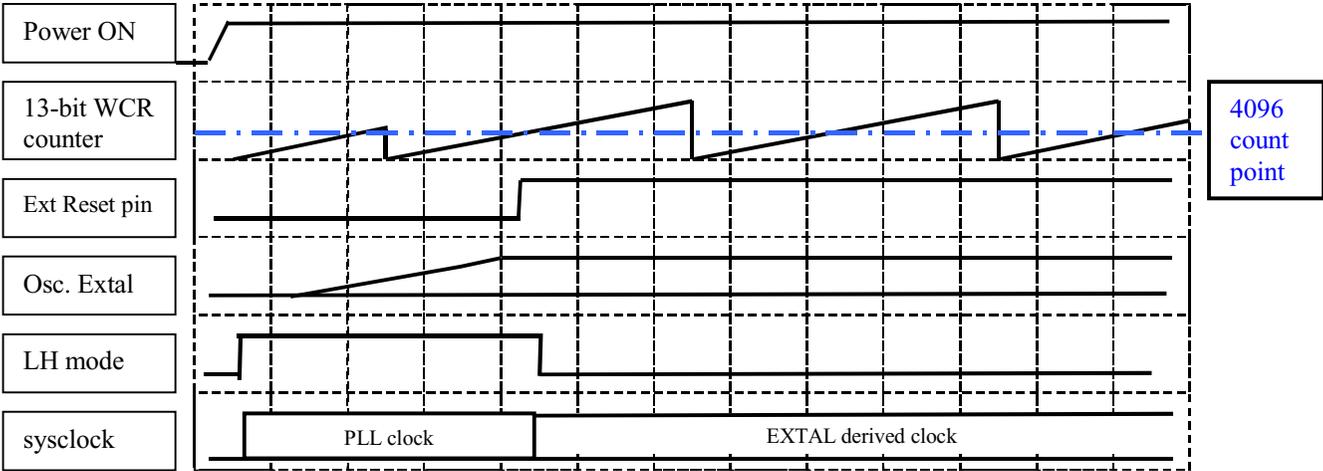
Figure 1. Representation of Normal start-up condition

Common practice for the start up mode of operation of HC12 microcontrollers is for the external RESET line to be held active until such time as the crystal has stabilized at its operating frequency. On release of the external RESET line and when the WCR (counter register) reaches a count of 4096 cycles, normal operating mode is entered with the CPU clocked from the crystal frequency (see fig. 1).

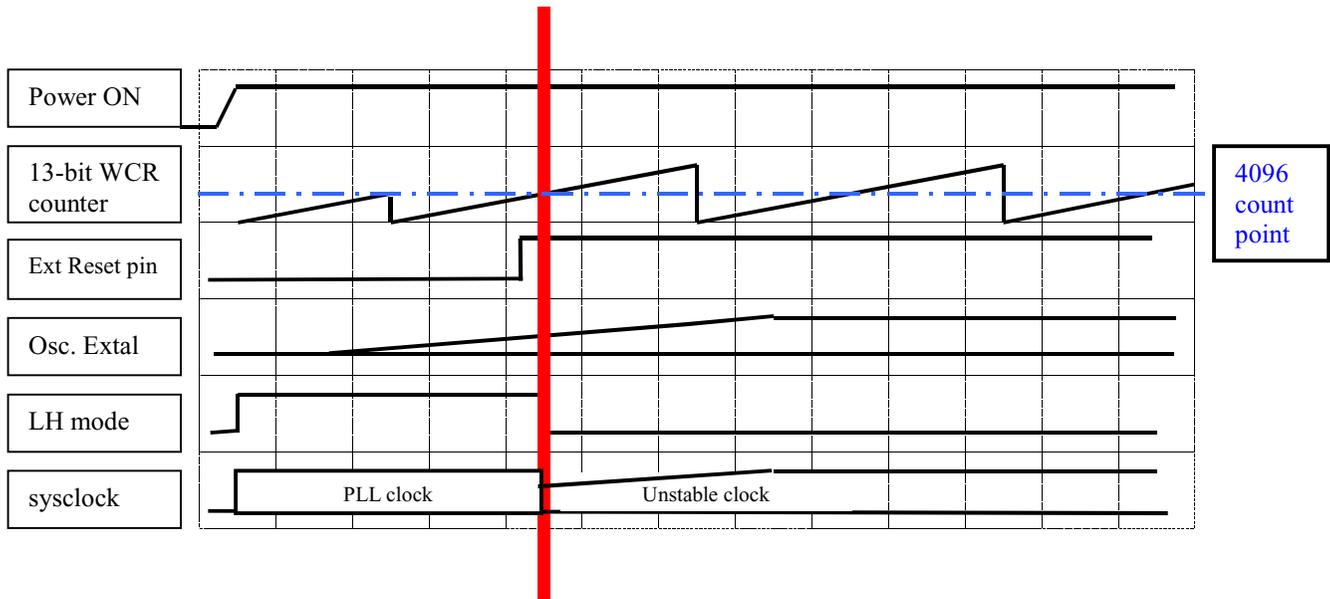
Figure 2. Representation of unreliable start-up mode with slow crystal

The device can prematurely indicate that the oscillator has stabilized releasing the part from Limp Home clock mode to the oscillator clock mode with an unstable oscillator. This can cause unpredictable behavior of the MCU. This situation can arise with short external power-on reset periods and / or crystal oscillator circuits that exhibit slow startup characteristics. If the PLL is not being used (Vddpll connected to Vss) Limp Home mode is disabled and this issue does not apply.

For the first 4096 cycles i.e. during the internal reset period, Limp Home mode will be de-asserted if oscillator activity is detected by the clock monitor circuit - due to the asserted Reset signal there can be no CPU activity during the Reset phase. Following release of the external or internal POR RESET in LHM (whichever is later) the crystal oscillator is sampled by the clock monitor circuit after another 4096 VCO clock cycles and at intervals of 8192 clock cycles thereafter until the crystal is deemed to be operating. If the crystal oscillator is showing activity at the time it is checked then it will be deemed to be good, even though it may not have fully stabilized, and LHM will be de-asserted. This can cause the device to switch from LH mode to normal mode with the CPU clocked from an unstable signal from the crystal oscillator (see fig. 2) resulting in unpredictable function of the CPU.

The Reset condition can be overcome by allowing the crystal oscillator circuit to stabilize before releasing the external RESET line (see fig. 3). Operation is similar to that shown in fig 2.

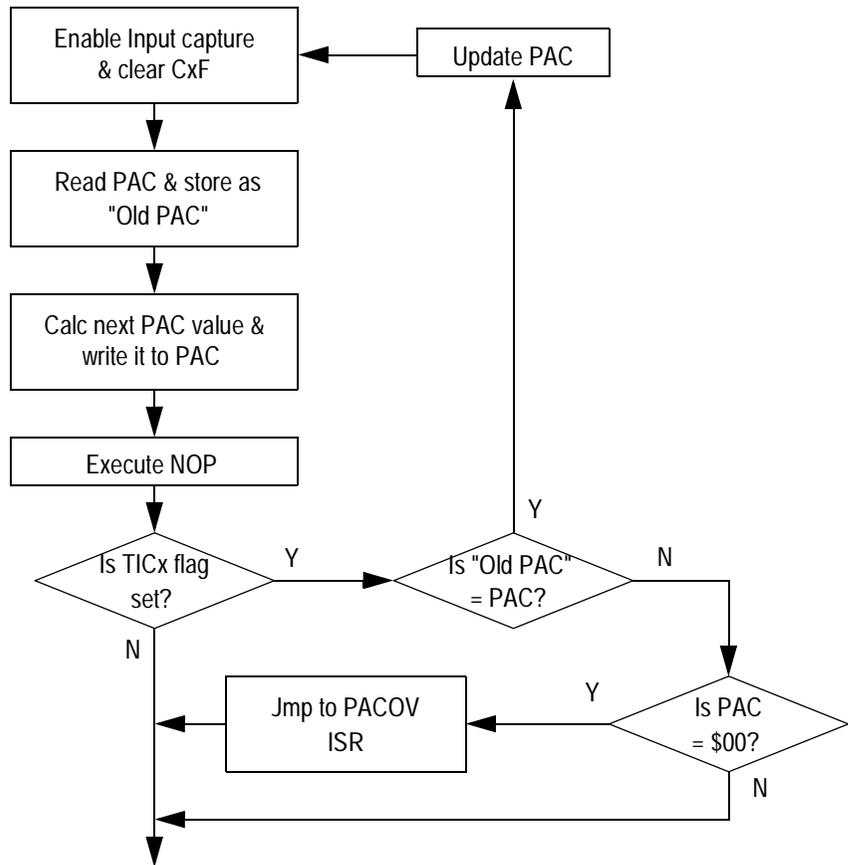
Description When the value \$FFFF is written to PACA or PACB and, at the same time, an external clocking pulse is applied to the PAC, the pulse accumulator may overflow from \$FFFF to \$0000, but the pulse accumulator overflow flag [PAFLG,PBFLG] is not set. Same situation may happen with 8-bit pulse accumulators PAC1 and PAC3.

Workaround The input capture function for the subject channel be enabled prior to writing a value to the PACA or PACB. Write to the pulse accumulator register. Then do one NOP (to allow the input capture to update the interrupt flag) followed by a read of the input capture interrupt flag to see if it set. If yes, a check must be made for a missing pulse accumulator event. Steps for software workaround to see if event happens while writing to PAC:

1. Enable Input Capture on same pin as the pulse accumulator (and same type of event).
2. Clear the appropriate CxF in the timer interrupt flag register.
3. Read PAC and store as "Old PAC".
4. Calculate desired PAC value and write it to the PAC.
5. Execute 1 NOP.
6. Read CxF in the timer interrupt flag register.

If flag is not set, done (no events happened while writing to the PAC).

If flag is set read PAC

If "Old PAC" = PAC, then update PAC (event happened while writing to PAC and the PAC did not capture it). Note, if the updated PAC value is \$00 jump to PACOV ISR.

If "Old PAC" does not equal PAC, does PAC = \$00 ?

If yes, jump to PACOV ISR.

If no, done (event happened while writing to the PAC and PAC captured it). Read CxF in the timer interrupt.
