# Mask Set Errata for 68HC912DG128C, Mask 1M63Z

This mask set errata applies to this 68HC912DG128C MCU mask set:

- 1M63Z

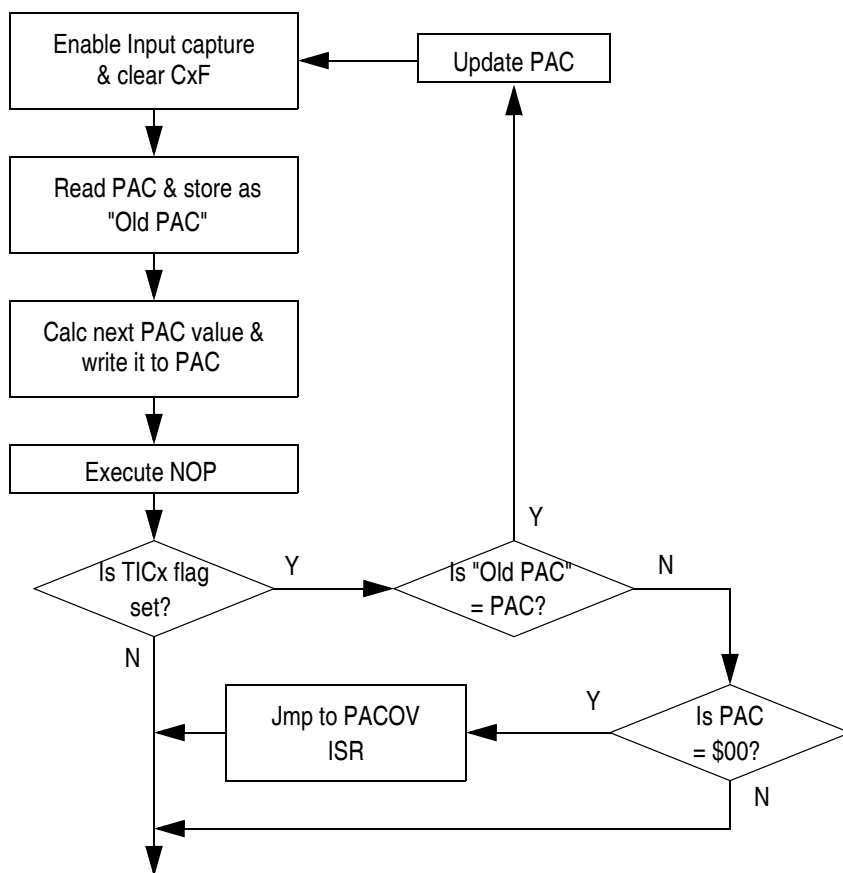
When the value \$FFFF is written to PACA or PACB and, at the same time, an external clocking pulse is applied to the PAC, the pulse accumulator may overflow from \$FFFF to \$0000, but the pulse accumulator overflow flag [PAFLG,PBFLG] is not set. Same situation may happen with 8-bit pulse accumulators PAC1 and PAC3.

The input capture function for the subject channel be enabled prior to writing a value to the PACA or PACB. Write to the pulse accumulator register. Then do one NOP (to allow the input capture to update the interrupt flag) followed by a read of the input capture interrupt flag to see if it set. If yes, a check must be made for a missing pulse accumulator event. Steps for software workaround to see if event happens while writing to PAC:

1. Enable Input Capture on same pin as the pulse accumulator (and same type of event).
2. Clear the appropriate CxF in the timer interrupt flag register.
3. Read PAC and store as "Old PAC".
4. Calculate desired PAC value and write it to the PAC.
5. Execute 1 NOP.
6. Read CxF in the timer interrupt flag register.

If flag is not set, done (no events happened while writing to the PAC).

If flag is set read PAC

If "Old PAC" = PAC, then update PAC (event happened while writing to PAC and the PAC did not capture it). Note, if the updated PAC value is \$00 jump to PACOV ISR.

If "Old PAC" does not equal PAC, does PAC = \$00 ?

If yes, jump to PACOV ISR.

If no, done (event happened while writing to the PAC and PAC captured it). Read CxF in the timer interrupt.
