Mask Set Errata

MSE912DT128C_1L05H
Rev 0.0, 01/2003

Mask Set Errata for
68HC912DT128C
Mask 1L05H

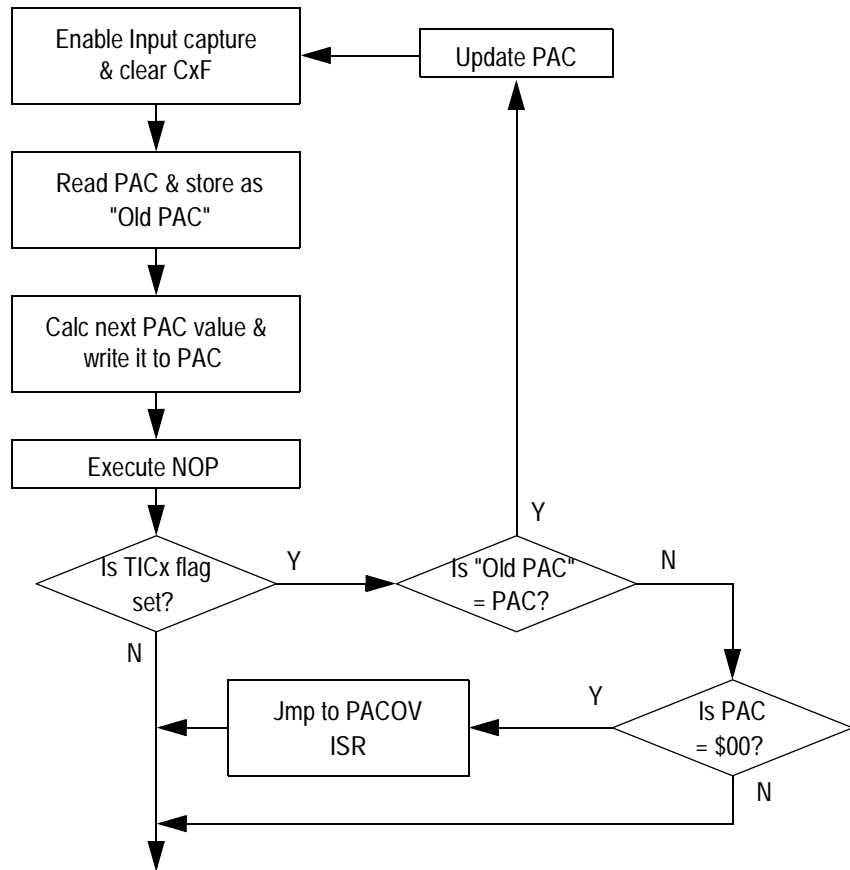
When the value \$FFFF is written to PACA or PACB and, at the same time, an external clocking pulse is applied to the PAC, the pulse accumulator may overflow from \$FFFF to \$0000, but the pulse accumulator overflow flag [PAFLG,PBFLG] is not set. Same situation may happen with 8-bit pulse accumulators PAC1 and PAC3.

The input capture function for the subject channel be enabled prior to writing a value to the PACA or PACB. Write to the pulse accumulator register. Then do one NOP (to allow the input capture to update the interrupt flag) followed by a read of the input capture interrupt flag to see if it set. If yes, a check must be made for a missing pulse accumulator event. Steps for software workaround to see if event happens while writing to PAC:

1. Enable Input Capture on same pin as the pulse accumulator (and same type of event).
2. Clear the appropriate CxF in the timer interrupt flag register.
3. Read PAC and store as "Old PAC".
4. Calculate desired PAC value and write it to the PAC.
5. Execute 1 NOP.
6. Read CxF in the timer interrupt flag register.

If flag is not set, done (no events happened while writing to the PAC).

If flag is set read PAC

If "Old PAC" = PAC, then update PAC (event happened while writing to PAC and the PAC did not capture it). Note, if the updated PAC value is \$00 jump to PACOV ISR.

If "Old PAC" does not equal PAC, does PAC = \$00 ?

If yes, jump to PACOV ISR.

If no, done (event happened while writing to the PAC and PAC captured it). Read CxF in the timer interrupt.
