Mask Set Errata for Mask 0M75B

This mask set errata applies to the mask 0M75B for these products:

- MC9S08AW60
 - MC9S08AW48
 - MC9S08AW32
 - MC9S08AW16
-

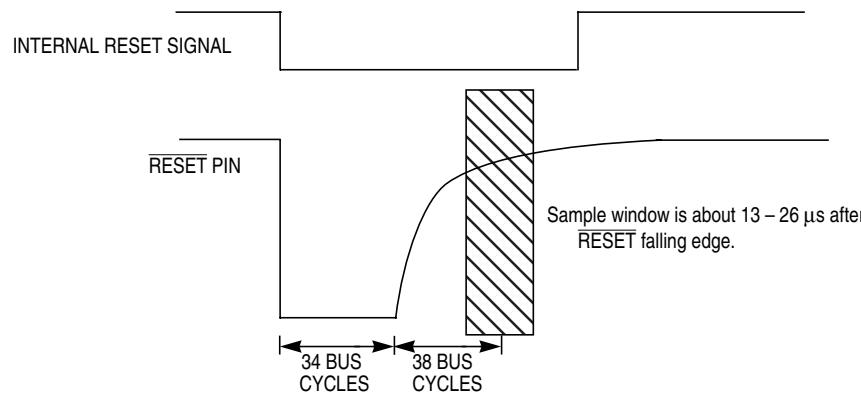
**Case 1**

If a falling edge is detected on the external reset pin at either of two sample points, the MCU will cease operation and will recover only after a power-on reset.

Case 1 — After detecting a reset signal, either internal or external, the internal reset circuit latches the cause of the reset, forces a low level on the external RESET pin for about 34 bus cycles, releases the pin, and samples the pin level about 38 bus cycles later. The ICG will revert to self-clock mode (SCM) at the beginning of the reset cycle. Therefore, the first sample window is about 13 μ s to 26 μ s after the initial reset signal, due to the frequency range and characteristics of the internal oscillator.

Workaround — Case 1

To avoid multiple edges on the RESET pin due to switch contact ringing or EMC noise, eliminate any voltage bounce through RC filtering. A 0.1 μ F capacitor to ground and an external 4.7 k Ω to 10 k Ω resistor to V_{DD} works well to ensure noise suppression.

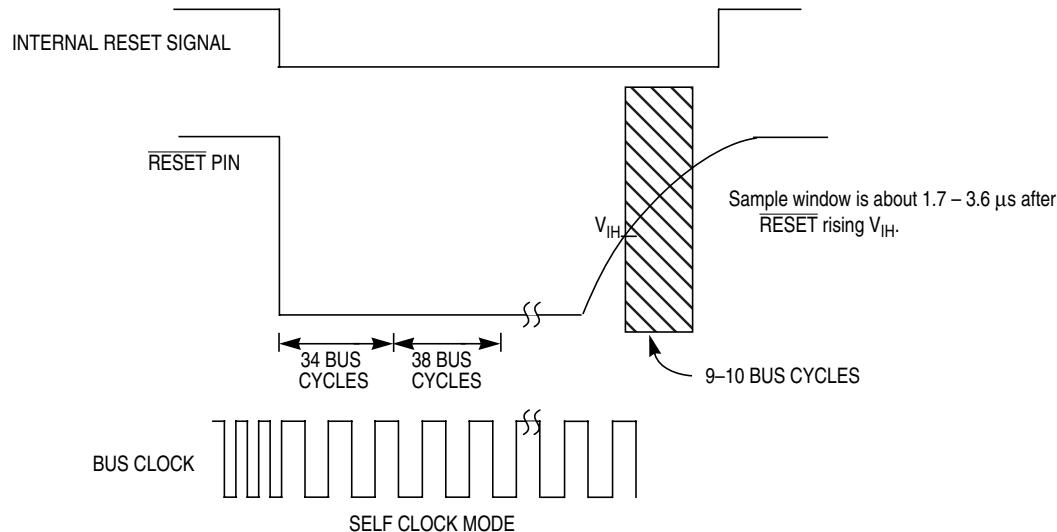
**Case 2**

Case 2 — After remaining in reset for an extended period of time due to an externally applied low level on RESET, the internal reset circuit will sample the pin level about 9 to 10 bus cycles after the pin raises above its V_{IH} level. The ICG will revert to self-clock mode (SCM) during reset. Therefore, the second sample window is about 1.7 μ s to 3.6 μ s after the reset signal rises above V_{IH} , due to the frequency range and characteristics of the internal oscillator.

Workaround — Case 2

In addition to RC filtering, avoid spurious edges on the $\overline{\text{RESET}}$ pin caused by external active circuitry such as low voltage detectors and watchdog components. Do this by ensuring that external circuitry cannot drive $\overline{\text{RESET}}$ low within 10 bus cycles of the release of $\overline{\text{RESET}}$.
