## Mask Set Errata for Mask 1M25G

This report applies to mask 1M25G for these products:

- MC9S08EL32
- MC9S08EL16
- MC9S08SL16
- MC9S08SL8

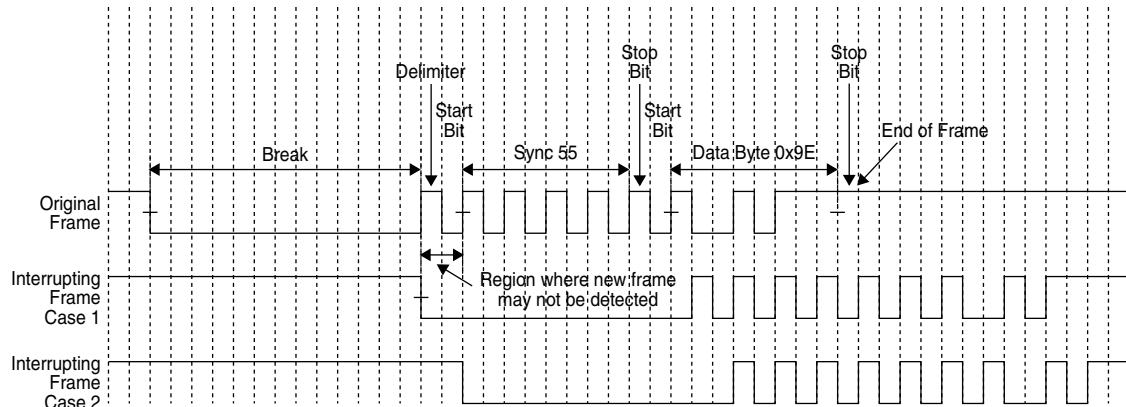
**Figure 1. Interrupting frame timing relative to the original frame**

**Description:** The Local Interconnect Network (LIN) specification 2.0 and later requires that a slave task always detects a break-sync sequence. Under specific conditions, the SLIC module does not always detect a new frame if it interrupts a frame that is currently being received. Both the following conditions must be met for the SLIC so that it fails to detect the new frame:

- the second frame, sent at the same LIN frequency, has a BREAK length that is shorter than the BREAK length of the existing frame.
- the falling edge of the second BREAK occurs between the rising edge of the first BREAK and the rising edge of the start bit of the SYNC 55 bytes.

The figure below shows the point in time during which the new frame may not be detected, assuming both messages are operating at the same frequency.

**Workaround:** The LIN Master implementation needs to be designed to prevent an existing frame from being interrupted during the period indicated in the figure below, assuming both messages are operating at the same frequency.

If multiple frequency LIN messages are used in the system, then the Master node should not interrupt any time from the beginning of the BREAK delimiter to the end of the Sync byte stop bit.

**NOTE:** The LIN message tolerance for the system needs to be taken into consideration and this time should be added to each end of the region where the new frame may not be detected.
