Mask Set Errata for Mask 3L11Y

This report applies to mask 3L11Y for these products:

- MC9S08GB60A
- MC9S08GT60A
- MC9S08GB32A
- MC9S08GT32A

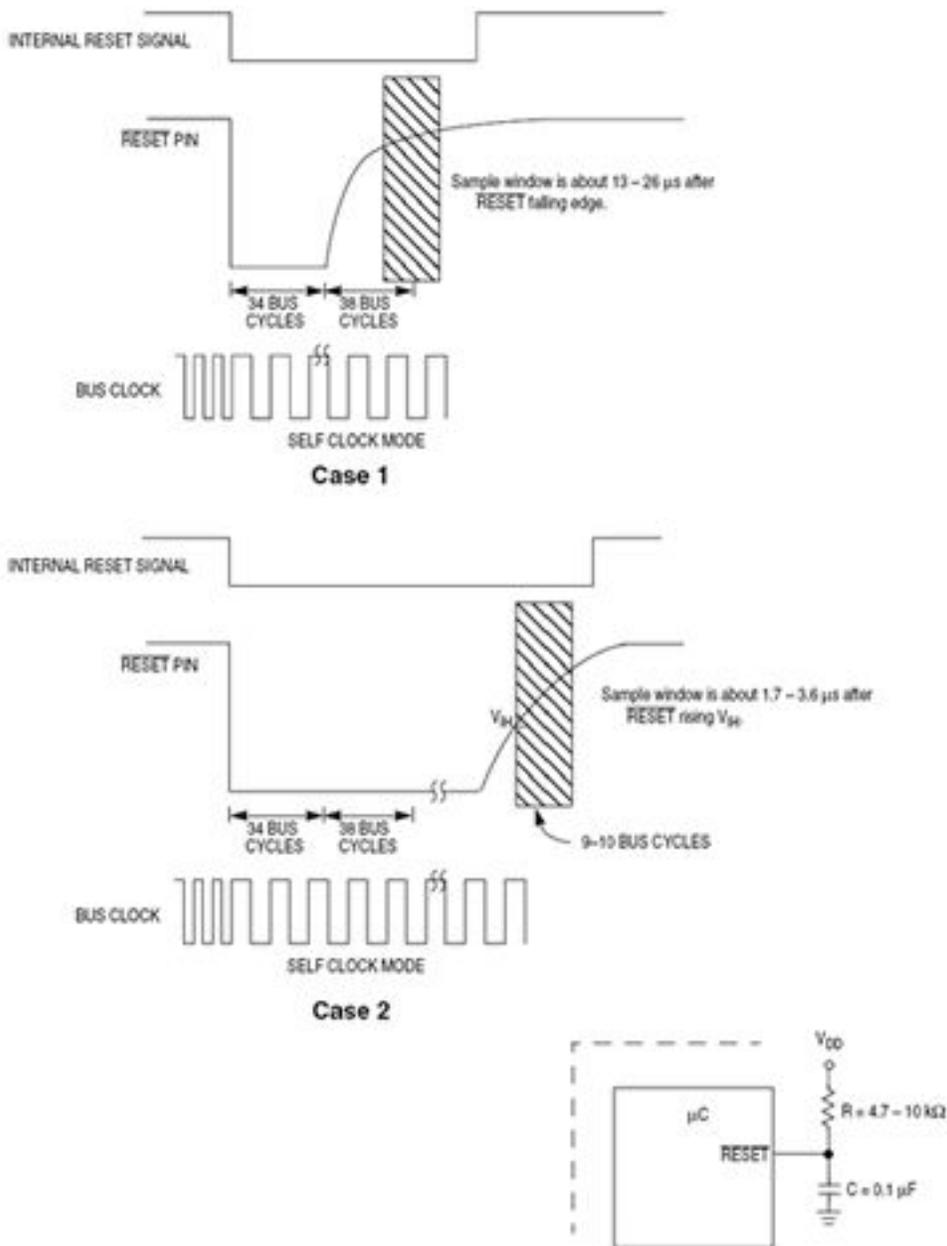
Figure 3. HCS08 SIM Reset Lockup

SE94A-Reset: HCS08 with ICG — Falling Edge on $\overline{\text{RESET}}$ During Termination of Reset Events

Description: If a falling edge is detected on the external reset pin at either of two sample points, the MCU will cease operation and will recover only after a power-on reset.

After detecting a reset signal, either internal or external, the internal reset circuit latches the cause of the reset, forces a low level on the external RESET pin for about 34 bus cycles, releases the pin, and samples the pin level about 38 bus cycles later. The ICG will revert to self-clock mode (SCM) at the beginning of the reset cycle. Therefore, the first sample window is about 13 μs to 26 μs after the initial reset signal, due to the frequency range and characteristics of the internal oscillator.

After remaining in reset for an extended period of time due to an externally applied low level on RESET, the internal reset circuit will sample the pin level about 9 to 10 bus cycles after the pin raises above its V_{IH} level. The ICG will revert to self-clock mode (SCM) during reset. Therefore, the second sample window is about 1.7 μs to 3.6 μs after the reset signal rises above V_{IH} , due to the frequency range and characteristics of the internal oscillator.

Workaround: To avoid multiple edges on the RESET pin due to switch contact ringing or EMC noise, eliminate any voltage bounce through RC filtering. A 0.1 μF capacitor to ground and an external 4.7 k Ω to 10 k Ω resistor to V_{DD} works well to ensure noise suppression.

In addition to RC filtering, avoid spurious edges on the RESET pin caused by external active circuitry such as low voltage detectors and watchdog components. Do this by ensuring that external circuitry cannot drive RESET low within 10 bus cycles of the release of RESET.
