Mask Set Errata for Mask 1M21A

This mask set errata applies to the mask 1M21A for these products:

- MC9S08RE16
- MC9S08RE8
- MC9S08RD16
- MC9S08RD8
- MC9S08RC16
- MC9S08RC8

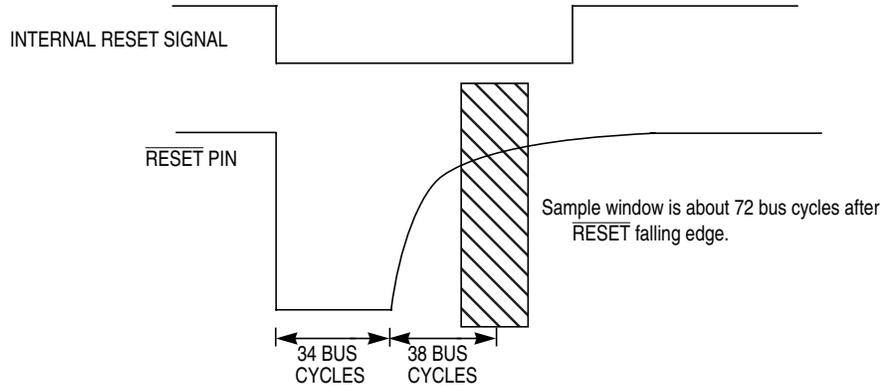
Case 1 — After detecting a reset signal, either internal or external, the internal reset circuit latches the cause of the reset, forces a low level on the external $\overline{\text{RESET}}$ pin for about 34 bus cycles, releases the pin, and samples the pin level about 38 bus cycles later.

To avoid multiple edges on the $\overline{\text{RESET}}$ pin due to switch contact ringing or EMC noise, eliminate any voltage bounce through RC filtering. A 0.1 μF capacitor to ground and an external 4.7 k Ω to 10 k Ω resistor to V_{DD} works well to ensure noise suppression.

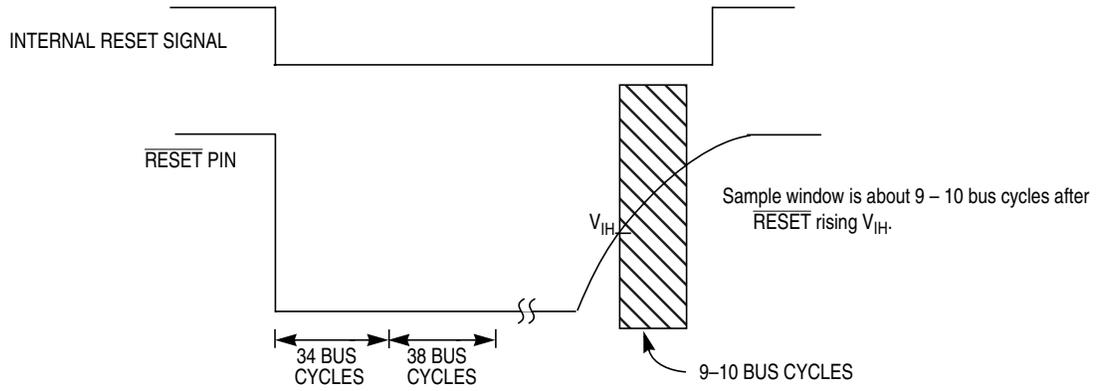
Case 2 — After remaining in reset for an extended period of time due to an externally applied low level on $\overline{\text{RESET}}$, the internal reset circuit will sample the pin level about 9 to 10 bus cycles after the pin raises above its V_{IH} level.

In addition to RC filtering, avoid spurious edges on the $\overline{\text{RESET}}$ pin caused by external active circuitry such as low voltage detectors and watchdog components. Do this by ensuring that external circuitry cannot drive $\overline{\text{RESET}}$ low within 10 bus cycles of the release of $\overline{\text{RESET}}$.
