# Mask Set Errata for Mask 0L33R

This mask set errata applies to the mask 0L33R for these products:

- MC9S08RG60
- MC9S08RG32
- MC9S08RE60
- MC9S08RE32
- MC9S08RD60
- MC9S08RD32
- MC9S08RC60
- MC9S08RC32

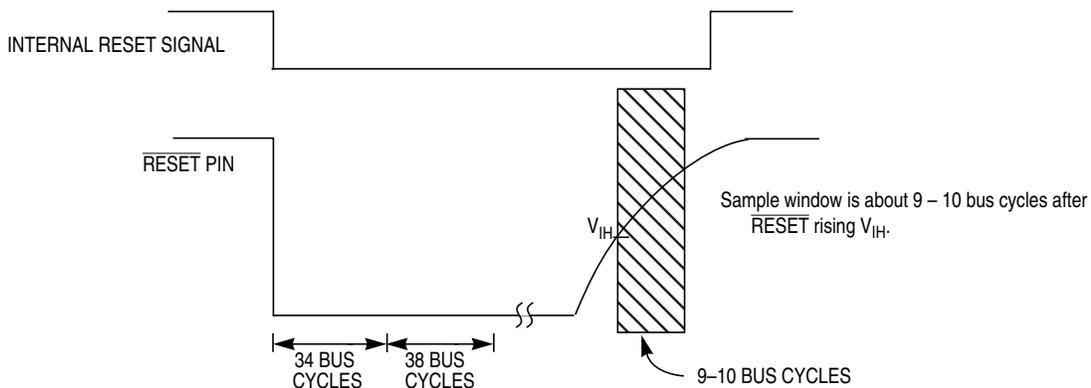
If a falling edge is detected on the external reset pin at either of two sample points, the MCU will cease operation and will recover only after a power-on reset.

**Case 1** — After detecting a reset signal, either internal or external, the internal reset circuit latches the cause of the reset, forces a low level on the external  $\overline{\text{RESET}}$  pin for about 34 bus cycles, releases the pin, and samples the pin level about 38 bus cycles later.

To avoid multiple edges on the  $\overline{\text{RESET}}$  pin due to switch contact ringing or EMC noise, eliminate any voltage bounce through RC filtering. A 0.1  $\mu\text{F}$  capacitor to ground and an external 4.7 k $\Omega$  to 10 k $\Omega$  resistor to  $V_{\text{DD}}$  works well to ensure noise suppression.

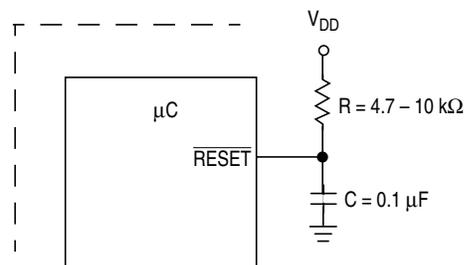
**Case 2** — After remaining in reset for an extended period of time due to an externally applied low level on  $\overline{\text{RESET}}$ , the internal reset circuit will sample the pin level about 9 to 10 bus cycles after the pin raises above its  $V_{IH}$  level.

In addition to RC filtering, avoid spurious edges on the  $\overline{\text{RESET}}$  pin caused by external active circuitry such as low voltage detectors and watchdog components. Do this by ensuring that external circuitry cannot drive  $\overline{\text{RESET}}$  low within 10 bus cycles of the release of  $\overline{\text{RESET}}$ .
