# **Errata for FXAS21002C**

## 2.1 E1: SPI Multipoint Communication

Document Number: FXAS21002CER Revision 0.1, 5/2015

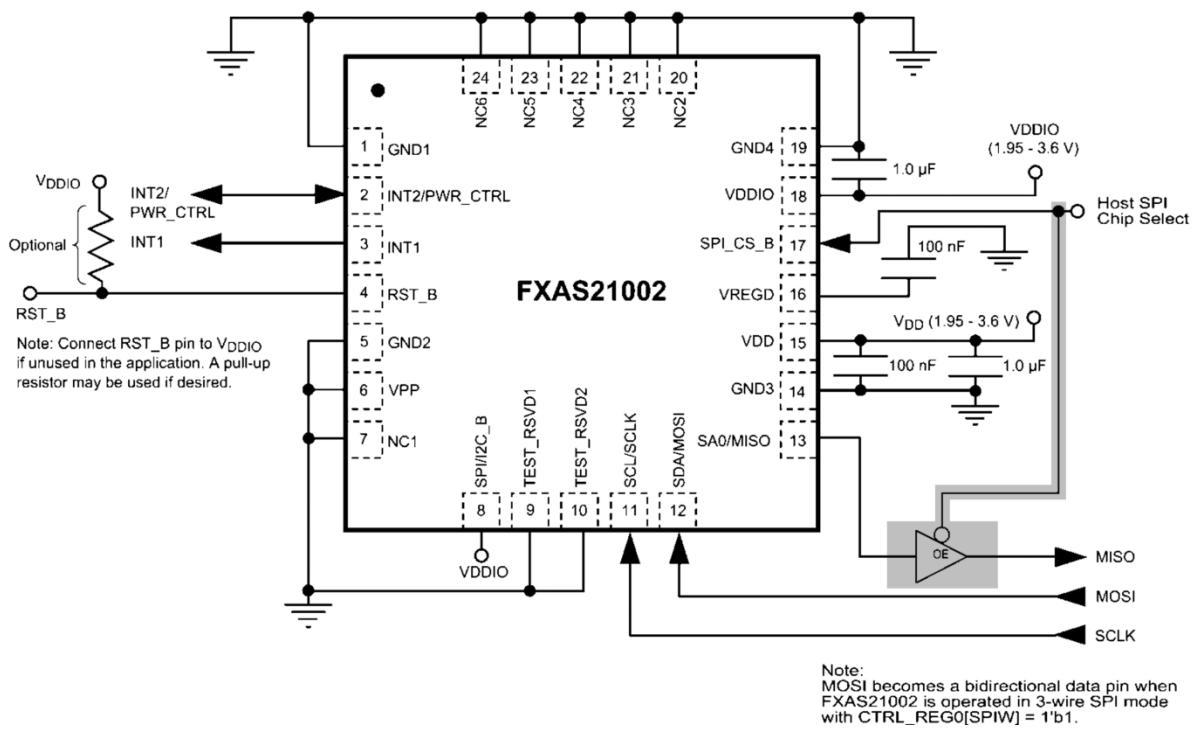
FXAS21002C, when connected for a 4-wire SPI communication with the master, does not tri-state the MISO line when the SPI\_CS\_B (SPI chip select, Active low) pin is deasserted (logic high). This leads to a bus conflict if there are multiple devices on the same SPI bus. As the part pulls MISO down to GND, instead of tri-stating, this part blocks the other slave devices on the bus from sending data to the master by means of 4-wire SPI communication.

Figure 1. Typical application circuit with addition of tri-state buffer

Add a tri-state buffer with the MISO line and the SPI\_CS\_B line as inputs to the buffer (see Figure 1).
