## *Mask Set Errata 1*

# **M68HC912D60 Microcontroller Unit**

This mask-set errata provides information pertaining to the following 68HC912D60 MCU mask set devices:

- 1F68K

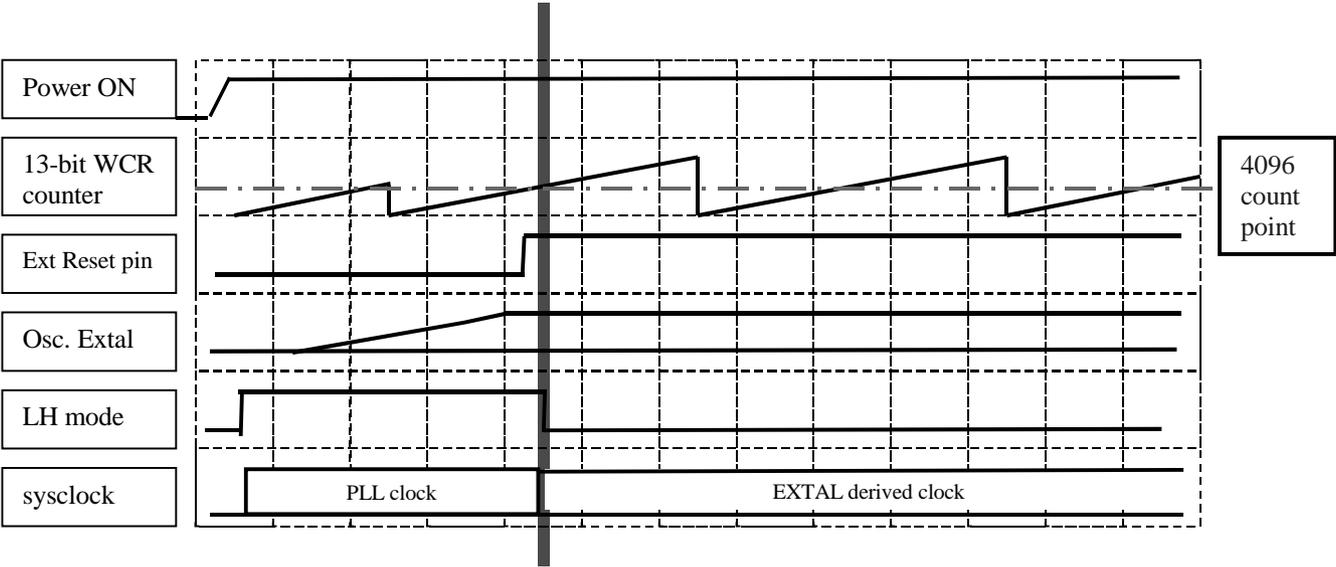
**Figure 1. Representation of Normal start-up condition**

The device can prematurely indicate that the oscillator has stabilized releasing the part from Limp Home clock mode to the oscillator clock mode with an unstable oscillator. This can cause unpredictable behavior of the MCU. This situation can arise with short external power-on reset periods and / or crystal oscillator circuits that exhibit slow startup characteristics. If the PLL is not being used (Vddpll connected to Vss) Limp Home mode is disabled and this issue does not apply.

when the WCR (counter register) reaches a count of 4096 cycles, normal operating mode is entered with the CPU clocked from the crystal frequency (see fig. 1).

When exiting Stop mode (DLY=1) a similar 4096 cycle delay is executed and therefore this behavior could also show up at this time. In applications where this is likely to be an issue, using pseudo-stop is recommended as an alternative. Current draw will increase <100  $\mu$ A at 4MHz in pseudo stop versus stop mode.

The Reset condition can be overcome by allowing the crystal oscillator circuit to stabilize before releasing the external RESET line (see fig. 3). Operation is similar to that shown in fig 2.

In some applications it may be possible avoid this issue by delaying the connection of Vddpll to Vdd until the device has exited reset. This will sacrifice the limp home mode safety function upon startup, i.e. the part will no longer be able to start without a functioning crystal. A similar technique (disable PLL under software control) can be used to overcome the limitations of Stop mode.
