Mask Set Errata for Mask 0M75B

This mask set errata applies to the mask 0M75B for these products:

- MC9S08AW60
 - MC9S08AW48
 - MC9S08AW32
 - MC9S08AW16
-

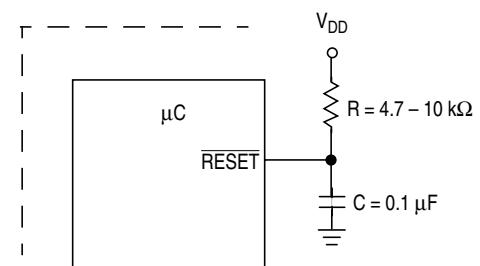
**Figure 1. HCS08 SIM Reset Lockup**

Case 1 — After detecting a reset signal, either internal or external, the internal reset circuit latches the cause of the reset, forces a low level on the external RESET pin for about 34 bus cycles, releases the pin, and samples the pin level about 38 bus cycles later. The ICG will revert to self-clock mode (SCM) at the beginning of the reset cycle. Therefore, the first sample window is about 13 μ s to 26 μ s after the initial reset signal, due to the frequency range and characteristics of the internal oscillator.

In addition to RC filtering, avoid spurious edges on the $\overline{\text{RESET}}$ pin caused by external active circuitry such as low voltage detectors and watchdog components. Do this by ensuring that external circuitry cannot drive $\overline{\text{RESET}}$ low within 10 bus cycles of the release of $\overline{\text{RESET}}$.
