# Mask Set Errata for Mask 0L33R

This mask set errata applies to the mask 0L33R for these products:

- MC9S08RG60
- MC9S08RG32
- MC9S08RE60
- MC9S08RE32
- MC9S08RD60
- MC9S08RD32
- MC9S08RC60
- MC9S08RC32

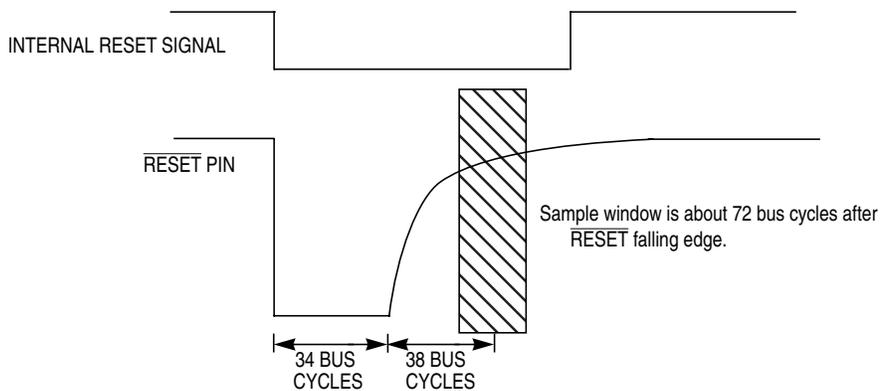
**Case 1** — After detecting a reset signal, either internal or external, the internal reset circuit latches the cause of the reset, forces a low level on the external  $\overline{\text{RESET}}$  pin for about 34 bus cycles, releases the pin, and samples the pin level about 38 bus cycles later.

In addition to RC filtering, avoid spurious edges on the  $\overline{\text{RESET}}$  pin caused by external active circuitry such as low voltage detectors and watchdog components. Do this by ensuring that external circuitry cannot drive  $\overline{\text{RESET}}$  low within 10 bus cycles of the release of  $\overline{\text{RESET}}$ .
