ERRATA SHEET

Date: April 17, 2002
Document Release: Version 1.0
Devices Affected: P87LPC768

Low pincount 8-bit microcontroller

P87LPC768

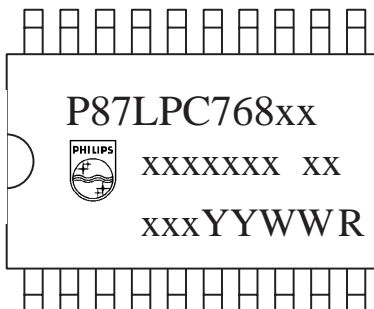
The typical P87LPC768 devices have the following top-side marking (SO 20 package shown):

The last letter in the third line (field 'R') will identify the device revision. This Errata Sheet covers the following revisions of the P87LPC768:

Field 'YY' states the year the device was manufactured. Field 'WW' states the week the device was manufactured during that year.
