# Freescale Semiconductor Reference Manual Addendum

# MCF5485 Reference Manual Errata

This errata document describes corrections to the *MCF5485 Reference Manual*, order number MCF5485RM. For convenience, the addenda items are grouped by revision. Please check our website at <a href="http://www.freescale.com/coldfire">http://www.freescale.com/coldfire</a> for the latest updates.

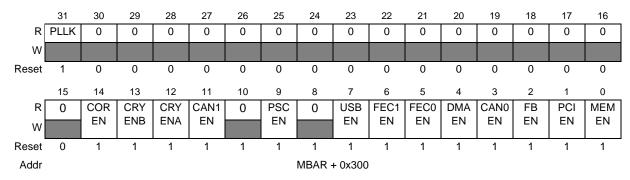
Figure 2. System PLL Control Register (SPCR)

The system PLL control register (SPCR) defines the clock enables used to control clocks to a set of peripherals. Unused peripherals can have their clock stopped, reducing power consumption. In addition, the SPCR contains a read-only bit for the system PLL lock status. At reset, the clock enables are set, enabling all system PLL gated output clocks.
