RELEASE NOTES

JN517x ZigBee 3.0 SDK

JN-SW-4270

Build 1841

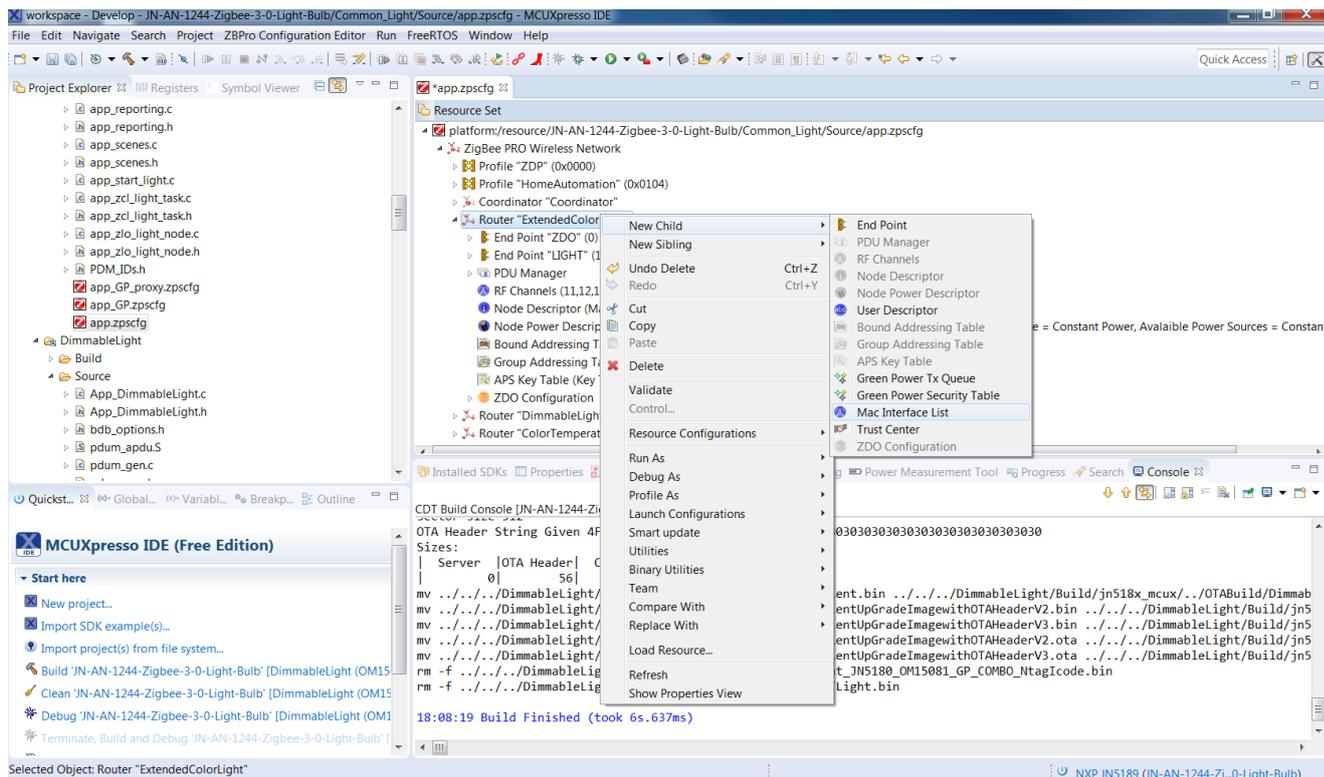
The Mac Interface list can be found as an option for the node. For e.g. if you have Zigbee network with a router node. You can select the router node and press the right mouse button to provide the options. The Mac Interface list can be found under New Child -> Mac Interface List.

The Zigbee PRO R22 version of the stack allows for multiple MAC interfaces to be present. This is to support both 2.4G and 868 MHz frequency bands using the single Zigbee stack. To address this a MAC interface table needs to be configured in the ZPS Config diagram.

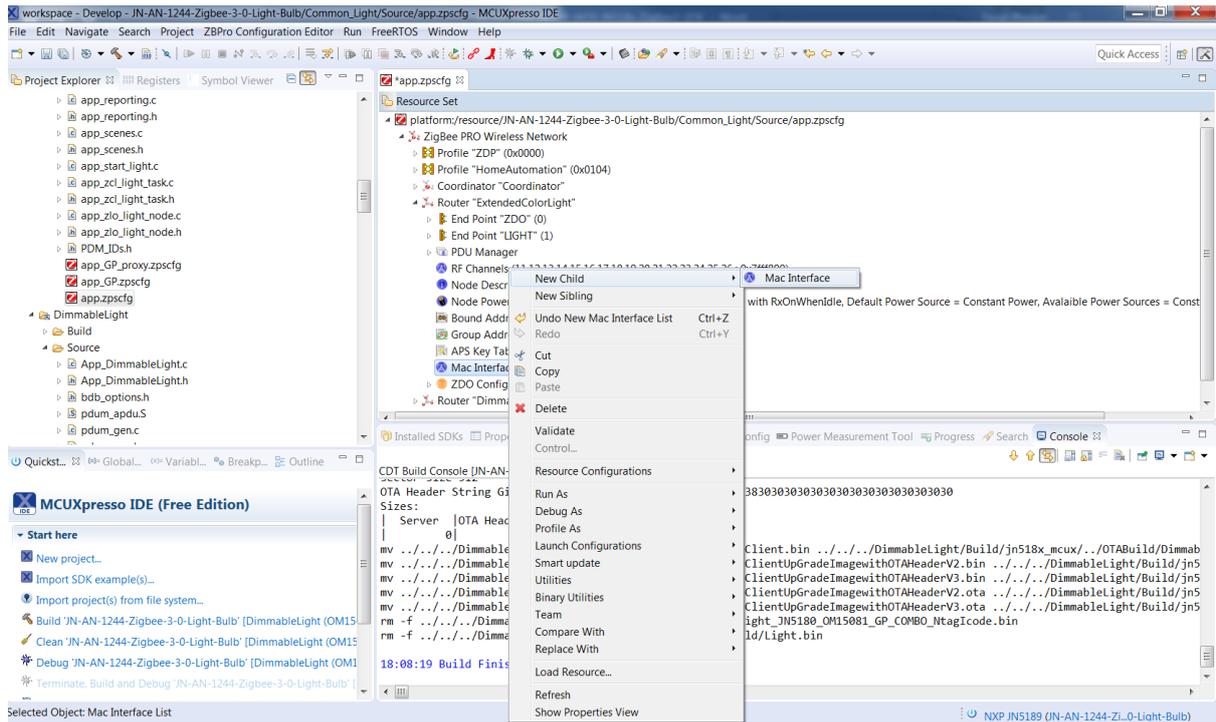
After adding the Mac Interface List, select the Mac Interface list and press the right mouse button to provide the options. The Mac interface can be found under New Child -> Mac Interface.

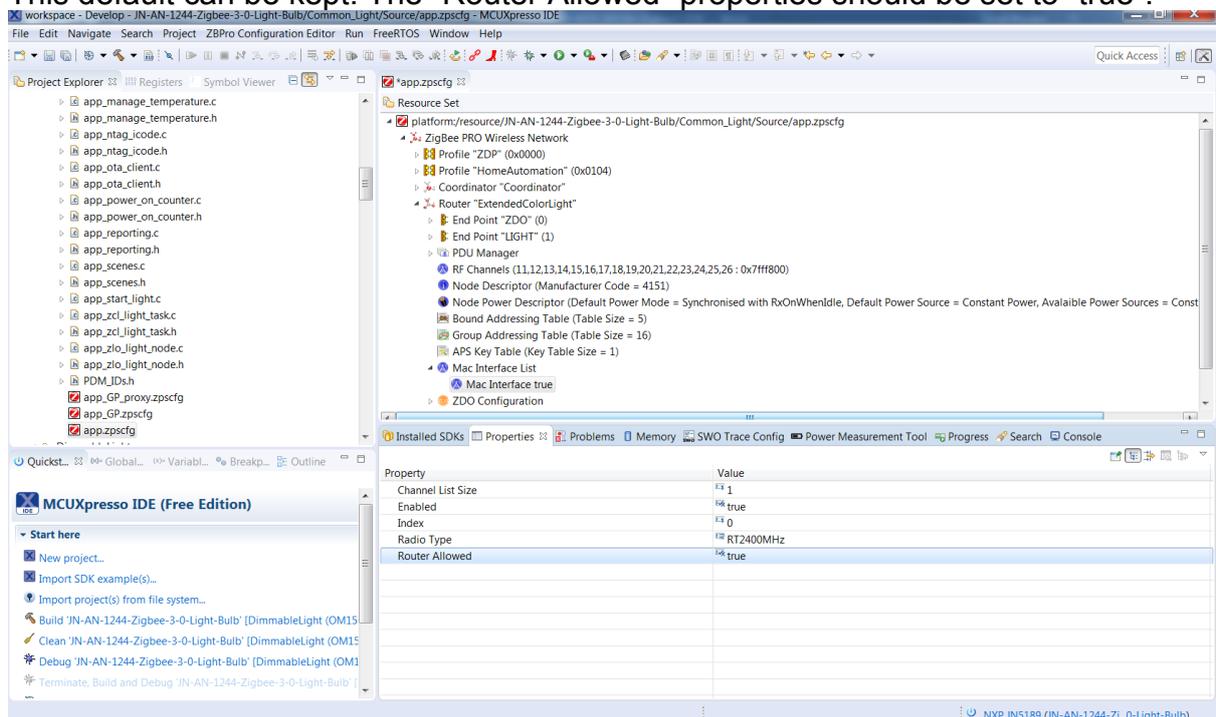
After adding the Mac Interface, the properties can be updated. The default is 2.4G. This default can be kept. The “Router Allowed” properties should be set to “true”.
