MPC5121e Functional Differences
2M34K and M36P
M. Ruthenbeck
12/2008

There are 3 major categories of the changes being made between the two mask sets, or revisions for the MPC5121e. These categories are 1) Feature enhancements, 2) System Enhancements, and 3) Bug fixes and maintaining pin compatibility between the 2 revisions.

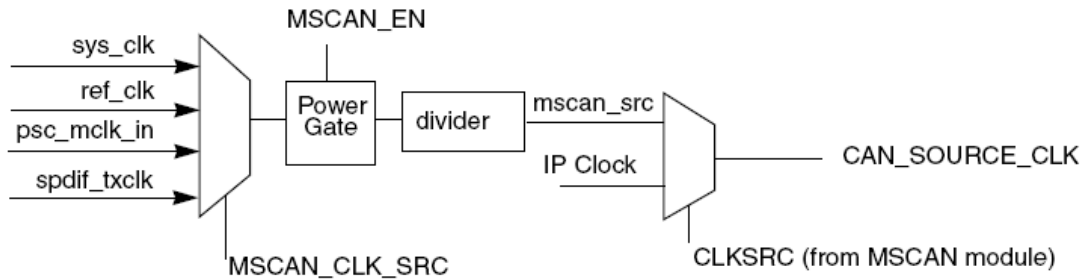
Can Clocking

The CAN clocking has been changed to enable greater granularity of the clock generation in support of additional CAN frequencies. The clock tree for the CAN has been implemented as follows:

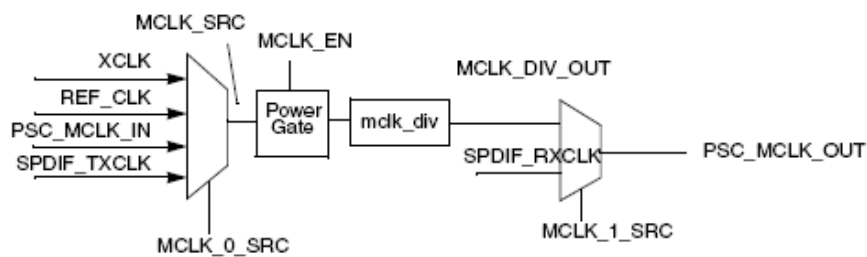
Figure 6-4. PSC (MCLK) Clock Generation¹

PSC Clock MCLK_DIV

The PSC MCLK_DIV has added a feature of a divide by 1, or pass through. The diagram below shows the “mclk_div” in the clock tree.
