Chip Errata for the i.MX 6UltraLite

This document details the silicon errata known at the time of publication for the i.MX 6UltraLite multimedia applications processors.

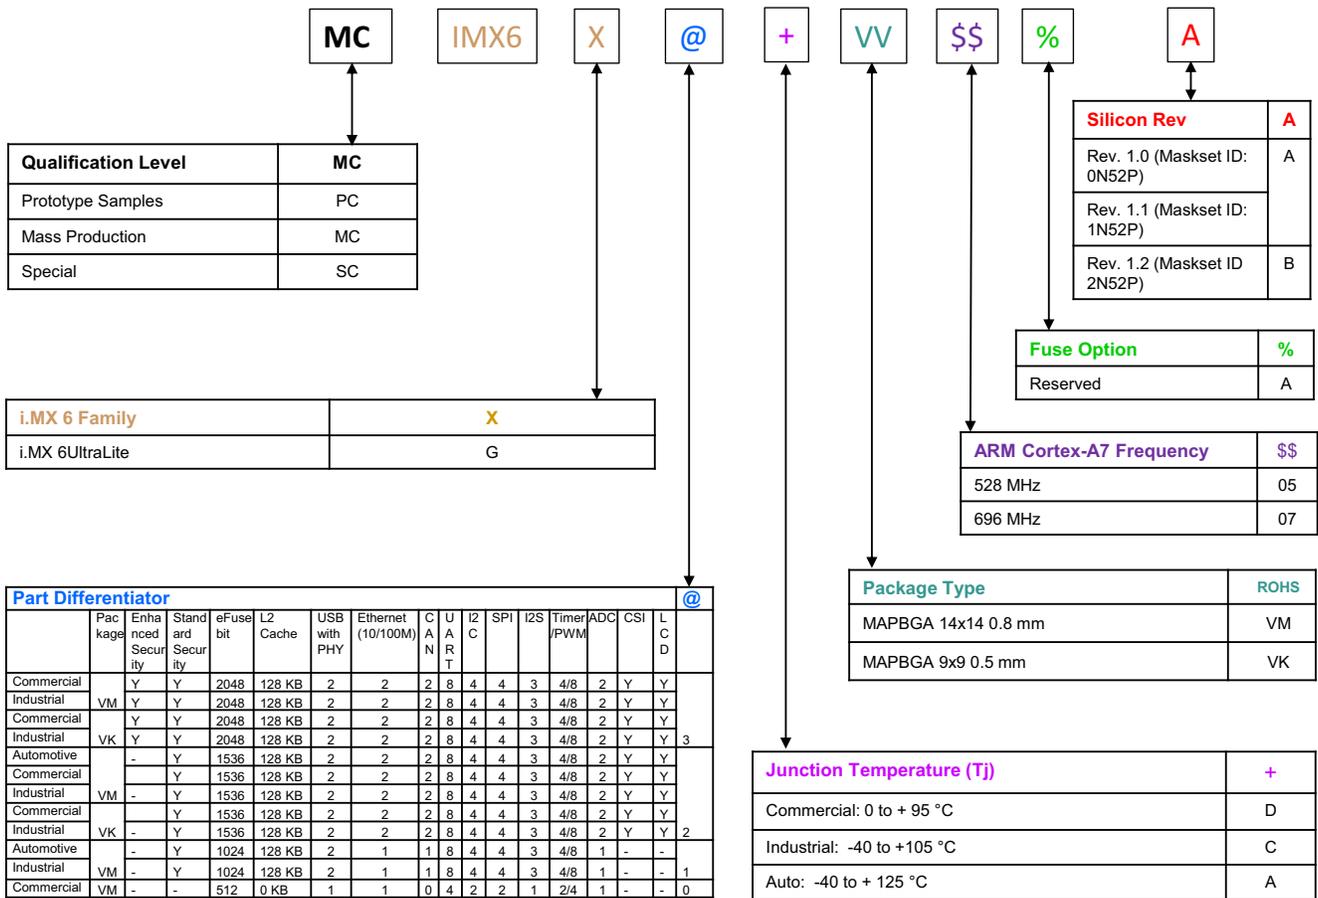
Figure 1. Revision Level to Part Marking Cross-Reference

Figure 1 provides a cross-reference to match the revision code to the revision level marked on the device.
