Chip Errata for the i.MX RT1050

This document details the silicon errata known at the time of publication for the i.MX RT1050 crossover processors.

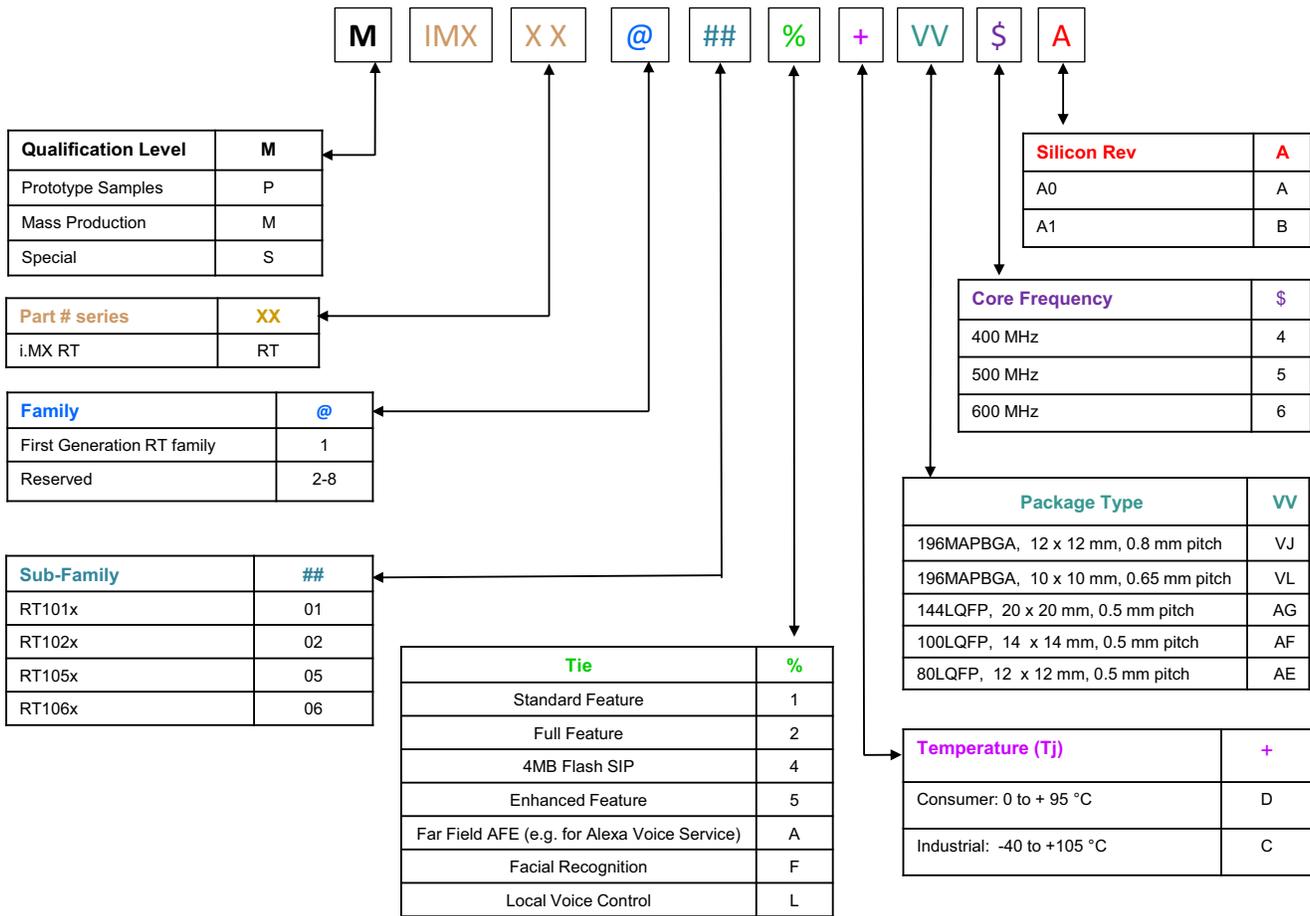
Figure 1. Revision Level to Part Marking Cross-Reference

Figure 1 provides a cross-reference to match the revision code to the revision level marked on the device.
