MPC8349E Chip Errata

This document details all known silicon errata for the MPC8349E family of chip errata. The following table provides a revision history for this document.

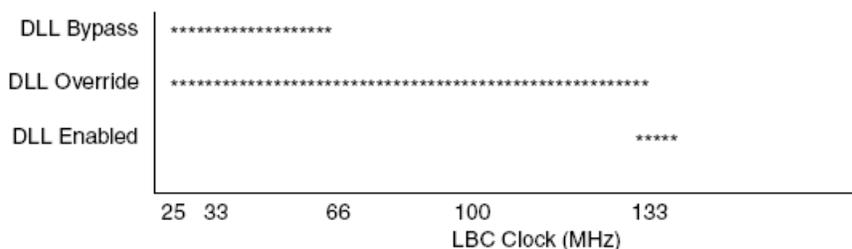
Workaround: This workaround (DLL override) is applicable for the device in DLL-enabled mode only. The recommended operating ranges for each of the LBC modes are as follows:

The following sequence of events is required at device boot-up to manually override the DLL:

1. Wait for $\overline{\text{HRESET}}$ to negate.
2. Program the LBC configuration registers accordingly, especially LCRR, setting LCRR[DBYP] = 0.
3. Wait for 100 microseconds (for example, in a loop), minimizing core activity.
4. Perform the following code sequence:
