# **RELEASE NOTES**

## **ZigBee Home Automation/Light Link SDK**

**JN-SW-4168**

**Build 1620**

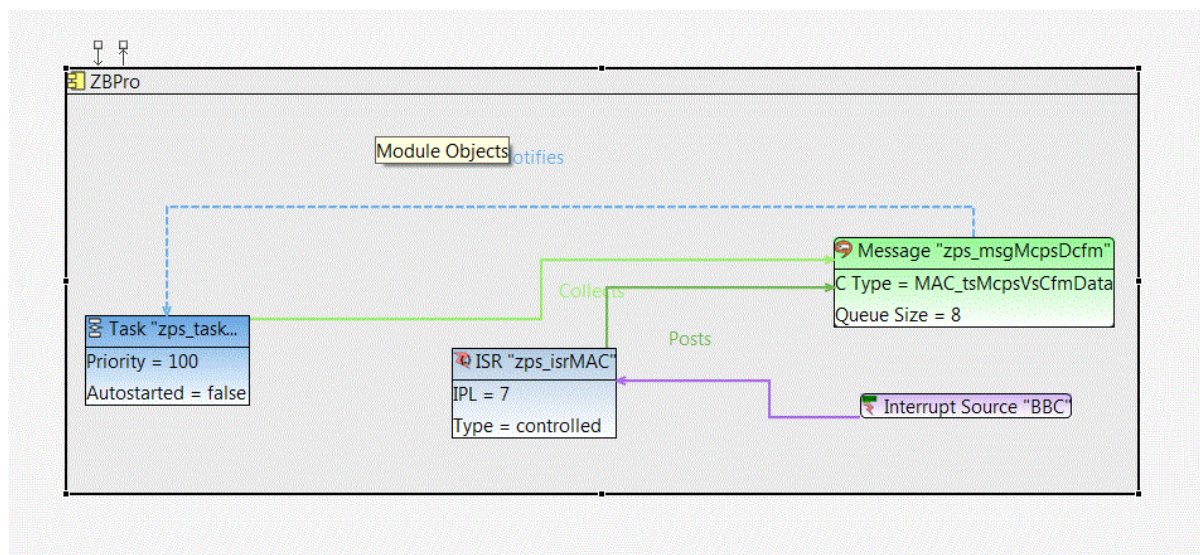
Figure 1

The Zigbee PRO stack requires an additional queue to increase its responsiveness to the high amount of traffic over the air. The queue is used to manage the asynchronous deferred confirmation of transmitted data requests submitted to the MAC/PHY interface. This new queue needs to be configured in the OS configuration diagram present in the application source code.

A new message queue should be added in the ZBPro stack scope box as shown in Figure 1. The properties of the queue should be setup as shown in Figure 2.

The relationships of the message queue “zps\_msgMcpsDcfm” , to the ISR “zps\_isrMAC” and the task “zps\_task is shown in the Figure 1.

The ISR “zps\_isrMAC” posts the deferred confirm message to the queue “zps\_msgMcpsDcfm”, The queue “zps\_msgMcpsDcfm” then “Notifies” the zps\_task, The zps\_task “Collects” the messages from the message queue “zps\_msgMcpsDcfm”.

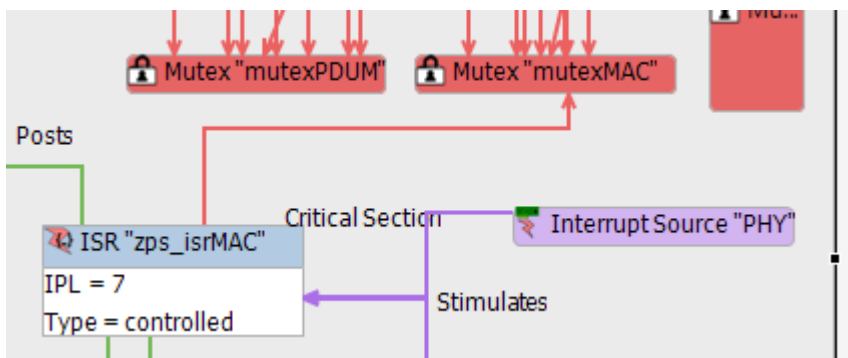
## 8.4.10 Removal of PHY Interrupt from OS Diagram

In earlier HA applications, the OS diagram contained a PHY interrupt source that stimulated the MAC ISR, as shown in the following example.

In the new SDK, the application needs to remove this interrupt source, since it is no longer required in the OS diagram.
