Test Report

號碼(No.): ETR23200368 日期(Date): 09-Feb-2023 頁數(Page): 1 of 4

樣品名稱(Sample Name) : MULAS

樣品型號(Style/Item No.) : MULAS W25-VMS-HC1, W-VMS-HC1

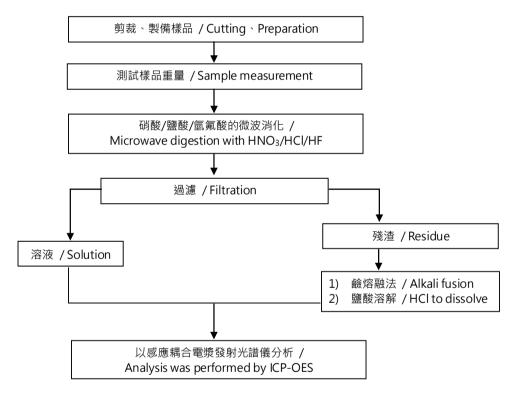
元素(含重金屬)分析流程圖 / Analytical flow chart of elements (Heavy metal included)

根據以下的流程圖之條件,樣品已完全溶解。

These samples were dissolved totally by pre-conditioning method according to below flow chart.

【參考方法/Reference method: US EPA 3051A、US EPA 3052】

* US EPA 3051A 方法未添加氫氟酸 / US EPA 3051A method does not add HF.

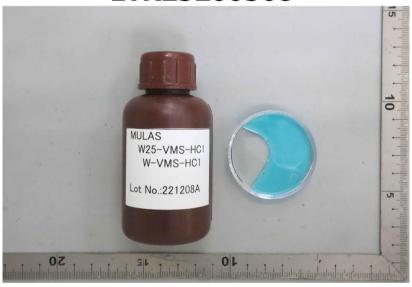
ETR23200368

* 照片中如有箭頭標示,則表示為實際檢測之樣品/部位. * (The tested sample / part is marked by an arrow if it's shown on the photo.)

No.1 : 藍色液體 (BLUE LIQUID)
